LIPPINCOTT PRESS BUILDING

Tech Notes

NUMBER 17

Repair and Retrofitting Industrial Steel Windows

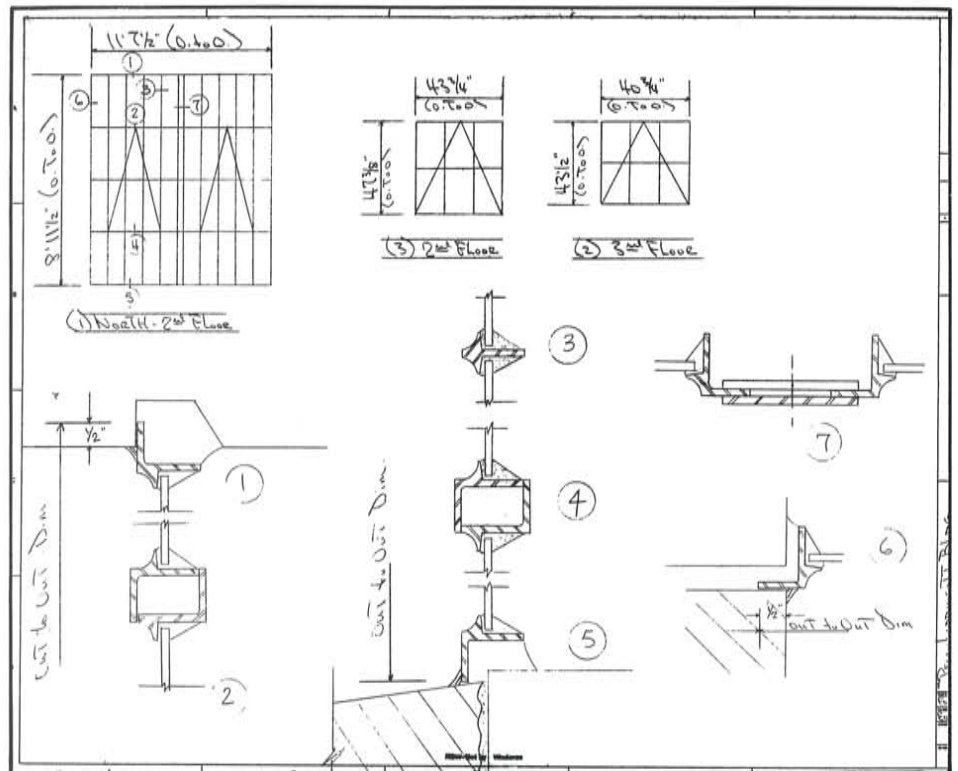
Figure 9. Sectional drawings of replacement window manufactured by A & S Window. Drawing: Winderco, Inc.

Once the muntins and mullions were set plumb, the final steps in the steel repair process began. In most of the sill areas, lengths of new steel sections were installed to replace the original corroded members. The new cavetto-shaped steel sections did not match exactly the bullnose profile of the historic windows (see figures 9 and 10). However, the original profile was no longer available and the new profile was close enough so that the overall proportions, profile, and shadow lines were compatible with the historic window appearance. The new steel sections at the sill and the lengths

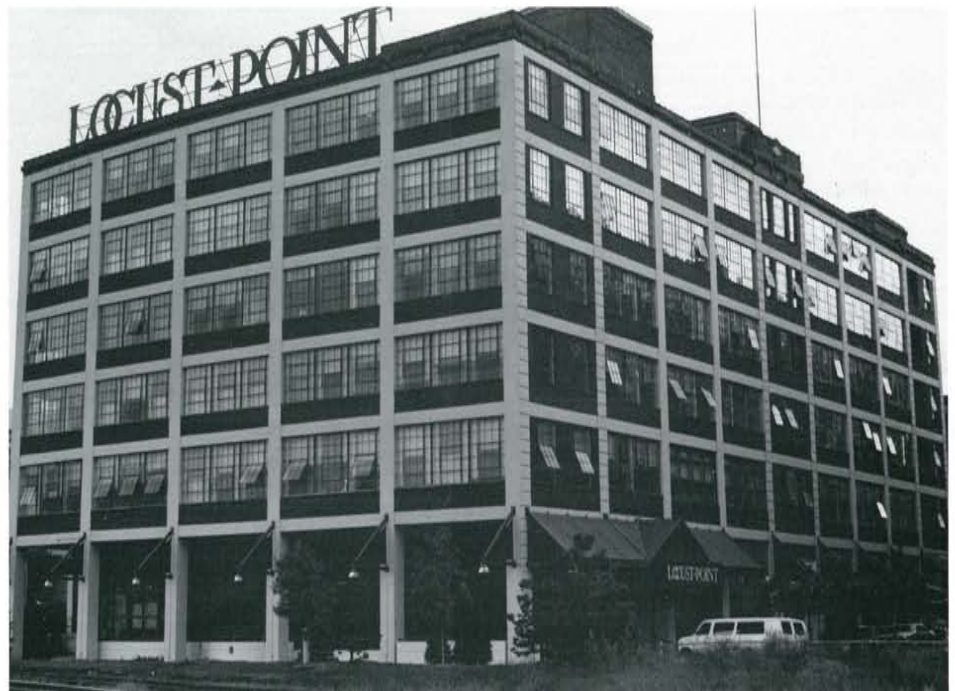
Figure 13. Lippincott Press Building (now Locust Point) after repair of the multi-light steel windows. Photo: Robert Powers.

and supervising the workers. For optimum paint performance and long-term maintenance, the repaired steel windows should have been sandblasted to fully remove the remaining paint and rust and to ensure a long-lasting bond between the steel and the new coats of paint. The additional cost would undoubtedly be justified by the more effective paint finish. Finally, although the storm window installed met the energy and overall visibility criteria established for the project, alternative schemes could have been developed that more closely reflected the operational and structural design of the historic steel window.
