Tech Notes

The Monadnock Building
Chicago, Illinois

Preserving Historic Office Building Corridors

Thomas G. Keohan
Division of Cultural Resources
Rocky Mountain Regional Office
National Park Service

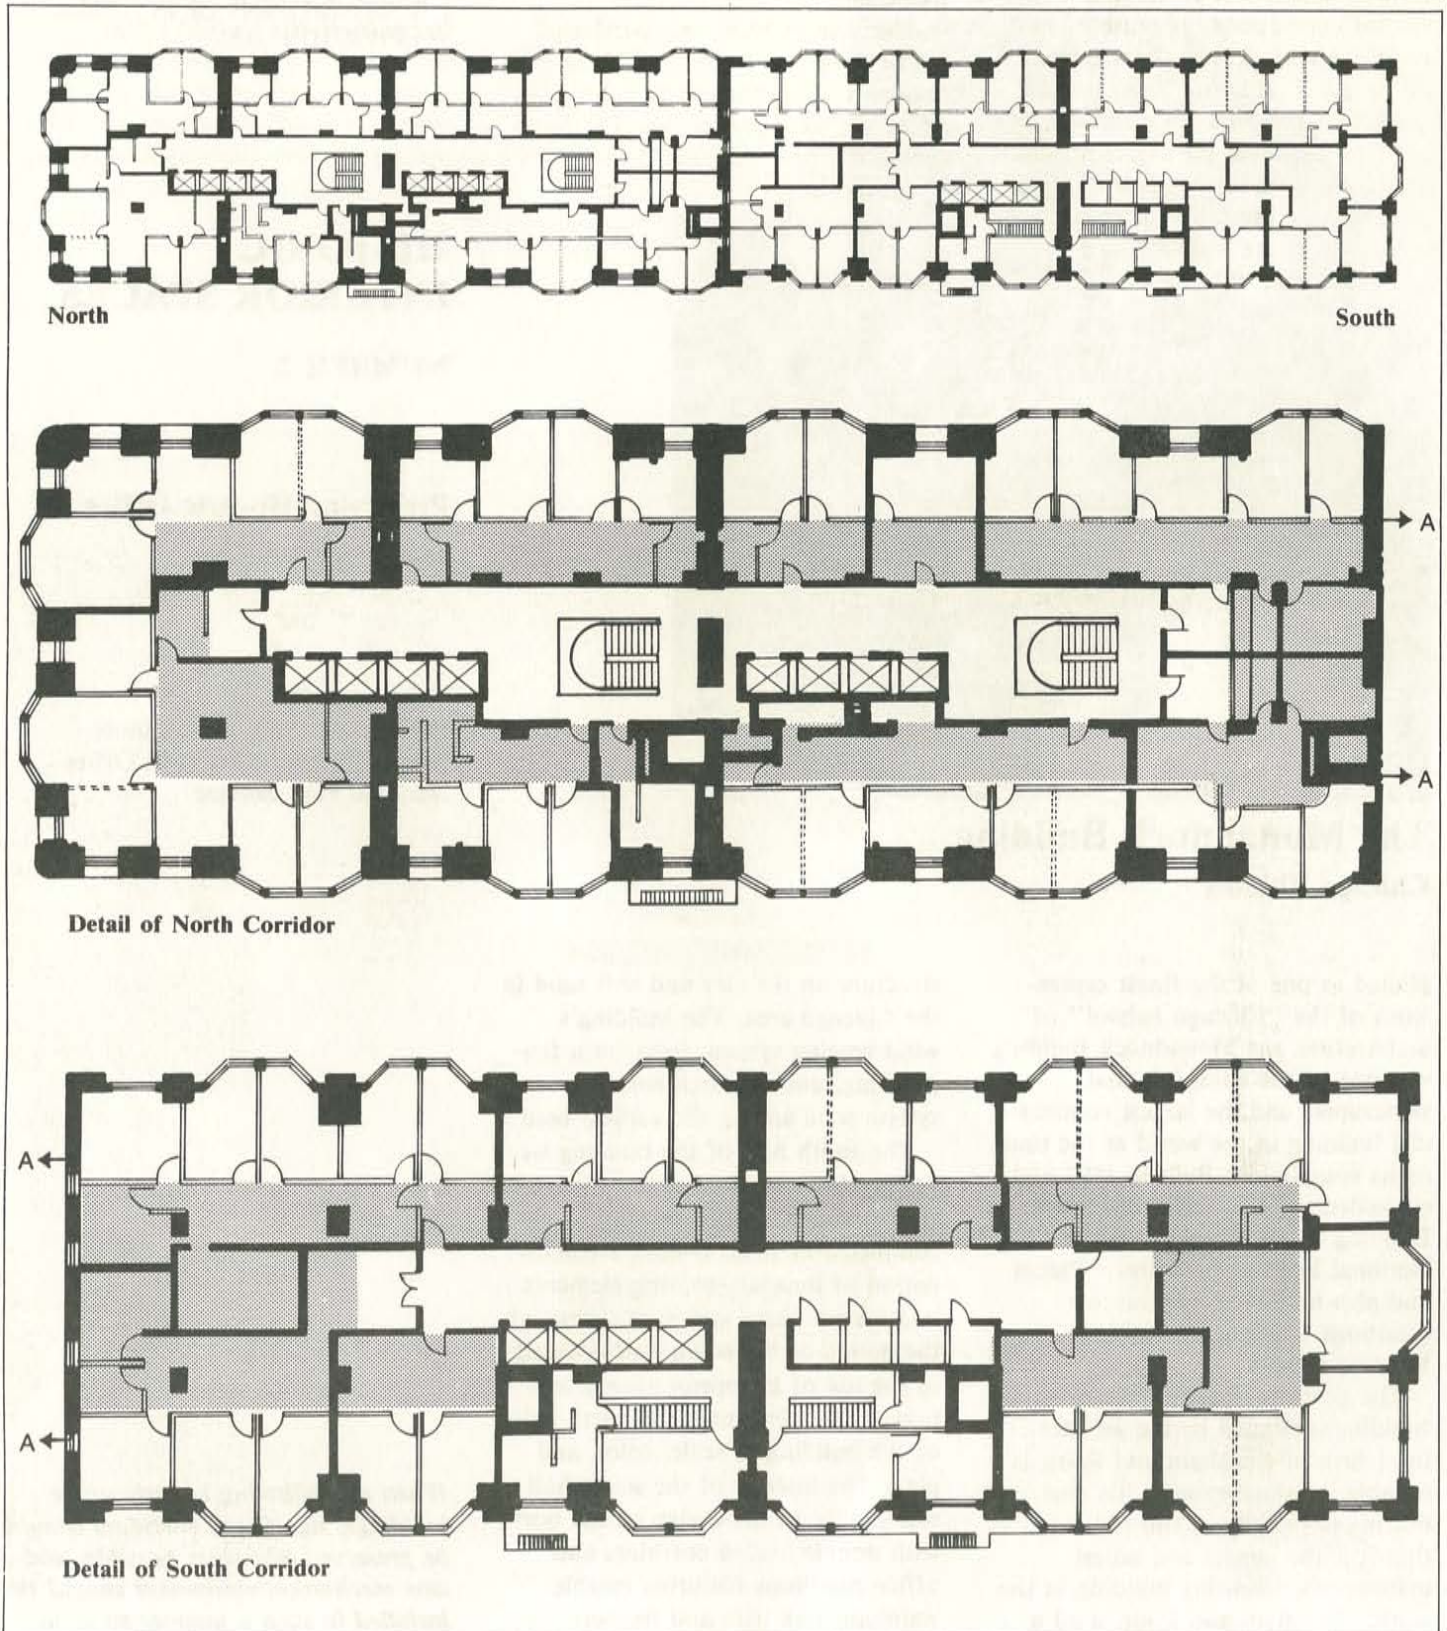
Figure 1. Both north and south building floor plan, showing double-loaded corridor system. Shaded area indicates dropped ceiling for mechanical chases in the non-public anterooms. Public corridors and private offices retain full ceiling height. Drawing: Neal Vogel

Typically, the ceilings in office building corridors are dropped to allow for mechanical chases to run longitudinally through the building. Retention of the Monadnock's historic plaster ceilings in the corridors was possible by locating mechanical systems above dropped ceilings in the non-public space adjacent to the corridors. These secretarial anterooms are located between the corridors and private office bays (See figures 1, 3, and 4).

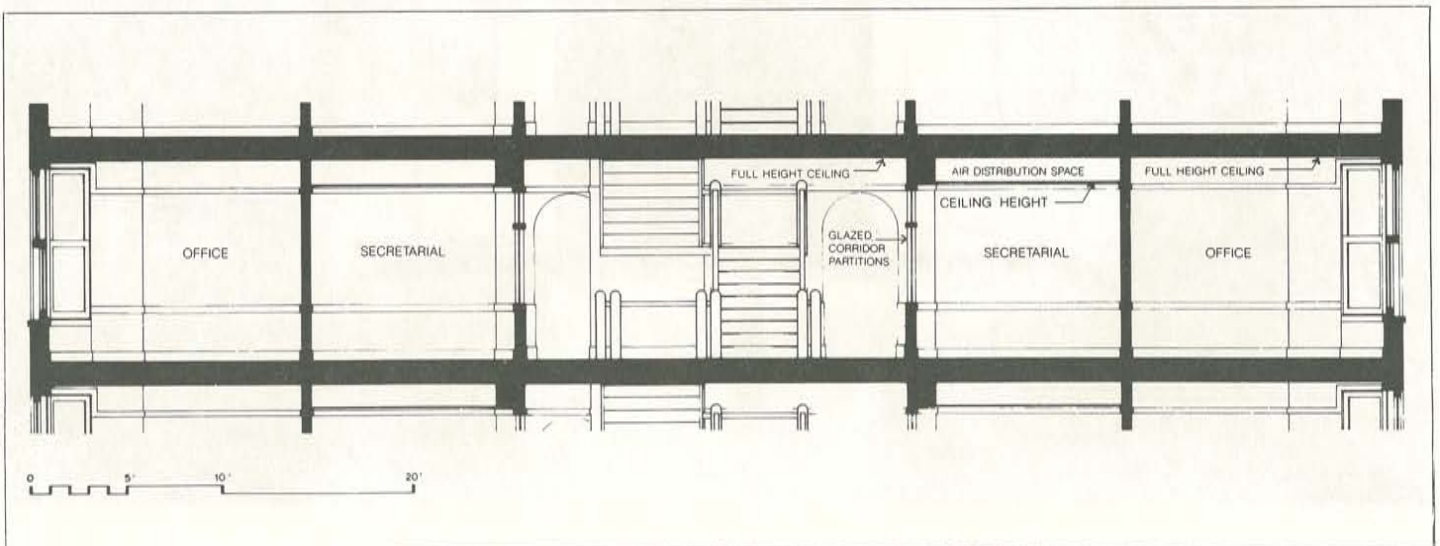
Figure 3. Building cross section showing open stairs and full height ceilings in corridors and private offices. Glazed corridor partitions are feather-chipped glass. Drawing: Montauk Company
