## **THE LAND TITLE BUILDING** **Philadelphia, Pennsylvania**

# **Tech Notes**

## **Stabilization and Repair of a Historic Terra Cotta Cornice**

**Jeffrey S. Levine**  
John Milner Associates

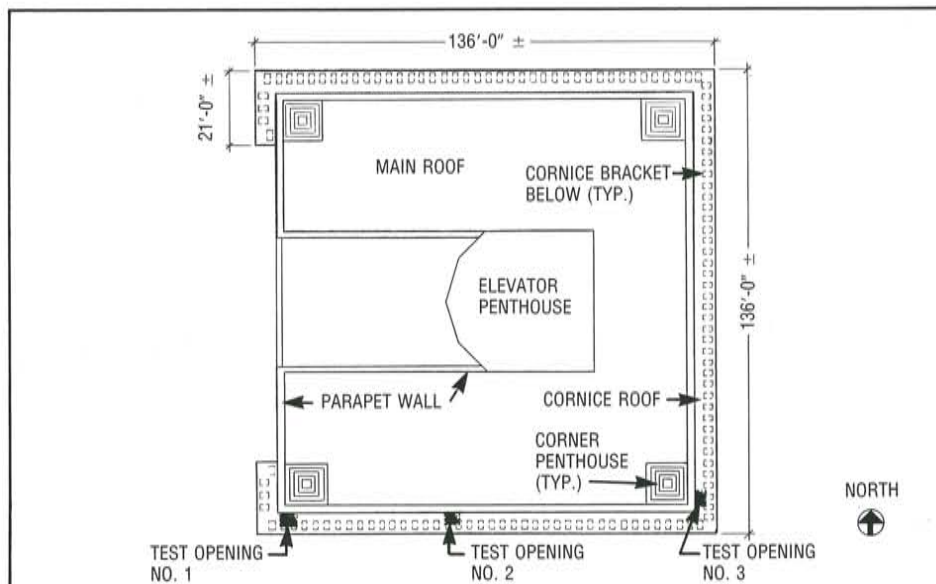
Figure 2. Roof plan of the 1902 tower showing the location of test openings in the cornice roof. Each bracket was later numbered consecutively so that easy reference could be made to a particular area of the cornice. Drawing by Jeffrey S. Levine.

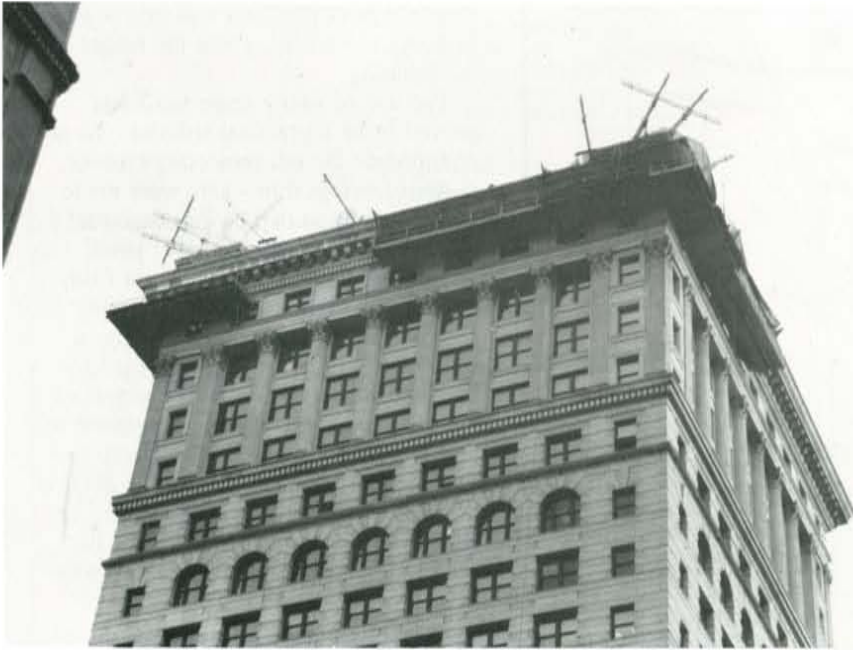
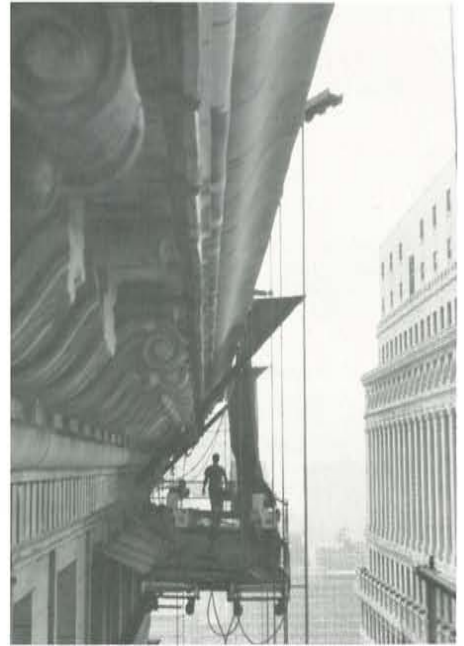
**Figure 8.** Access to the cornice was provided by cantilevered aerial scaffolds at the southeast and southwest corners of the cornice. All other locations were accessed by hanging two swing stages, side by side. The inner swing was hung off of a V-shaped bracket (shown) while the outer swing was hung from a steel deadman which projected horizontally across the cornice roof. Both the V-shaped bracket and the deadman were designed to transfer the weight of the swings vertically down through the center of the cornice. No load was placed on the outer edge of the cornice. Photos by Jeffrey S. Levine.

The use of swing-stage scaffolds proved to be a practical solution. To accommodate the tall projecting cornice, custom-fabricated brackets were made which permitted two swing-stage scaffolds to be hung side by side, parallel to and at a distance of about 2' out from the exterior wall. By tying the swing stages together and to the building, a stable work platform was provided for both the architect's detailed analysis of the cornice as well as the subsequent repair work (see figure 8). A narrow section of scaffolding placed on the deck of the swings allowed for work on the upper reaches of the cornice. Using 32' long swings, roughly 10 drops were required, with 1½ days of breakdown and setup time between drops. Two sets of double swings were employed for the job.

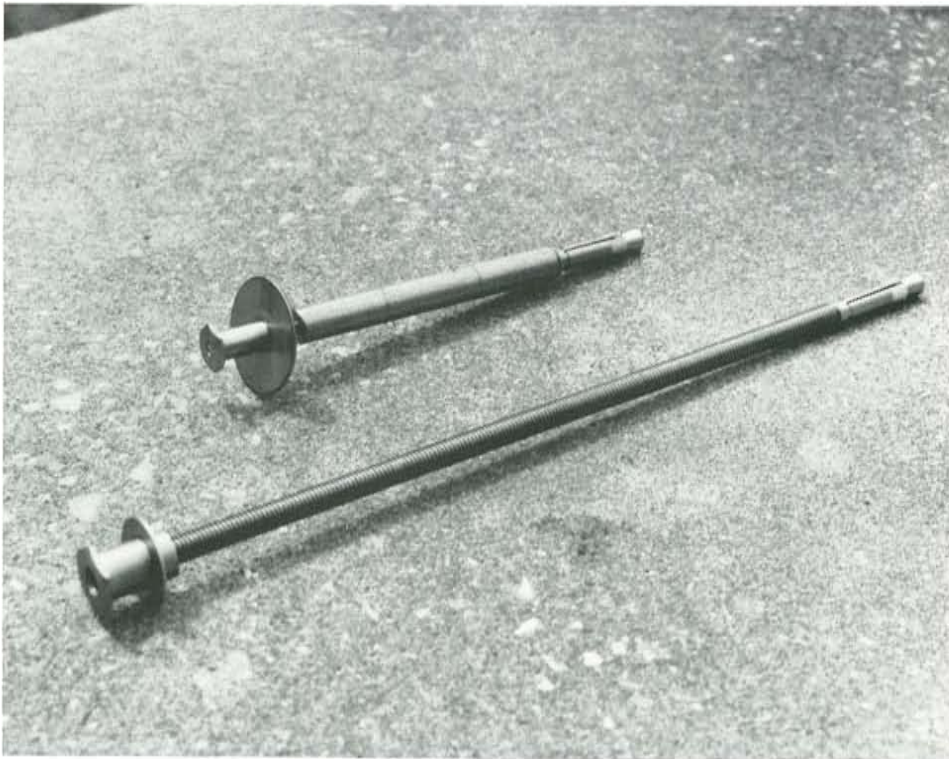
Figure 10. A standard mechanical anchor (top) and a variable length mechanical anchor. The variable length anchors were fabricated from 6' long threaded stainless steel rods, which were tapped at both ends to receive expansion assemblies (two anchors could be cut from each rod).

Stainless steel mechanical anchors,  $\frac{7}{16}$ " in diameter and with bronze expansion assemblies, were employed for most other anchoring needs (see figure 10). Anchors of various lengths were special ordered from the manufacturer. The specified lengths were established in the planning phase by drilling test holes in the cornice at what were thought to be typical anchoring locations. A variable length anchor was also developed for use in unanticipated locations and in areas of the cornice where the original construction differed materially from the area in which test borings were conducted (see figure 10).

unknown condition of the masonry backup. Pull-out tests were conducted on a large random sample of installed anchors. Utilizing a safety factor of four, very few anchors failed. Those that did fail had been anchored into masonry backup and were easily replaced after drilling deeper into the backup material.
