## 9 ROXBURY ROAD SCARSDALE, NEW YORK

## WINDOWS NUMBER 19

### Repairing Steel Casement Windows

Technical Preservation Services  
National Park Service

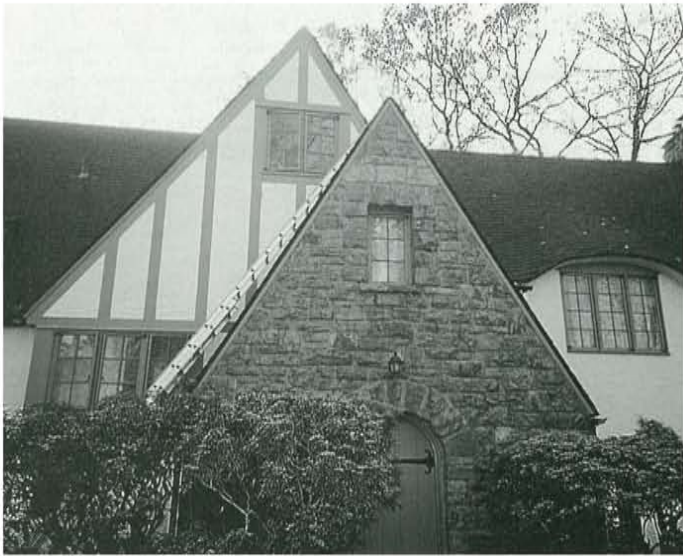
Figure 1. Steel casement windows were placed in various configurations throughout the house. Grouped windows open in opposite directions from each other, assuring that breezes can be captured, and a sash opened during rainy weather, regardless of the wind direction.

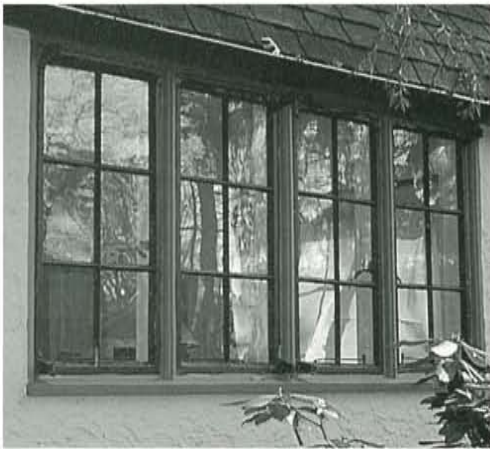
Figure 2. Each casement sash had six lights with projecting hinges that allowed the unit to open outward. Note the variation among glass panes as seen in the reflections. Caused by small differences in the positioning of panes within the sash and minor imperfections in the glass itself, this appearance is an important characteristic of historic windows.
