## ALDRIDGE HOTEL Shawnee, Oklahoma

# Preservation Tech Notes

## METALS NUMBER 6

### Repair and Reproduction of Metal Canopies and Marquees with Glass Pendants

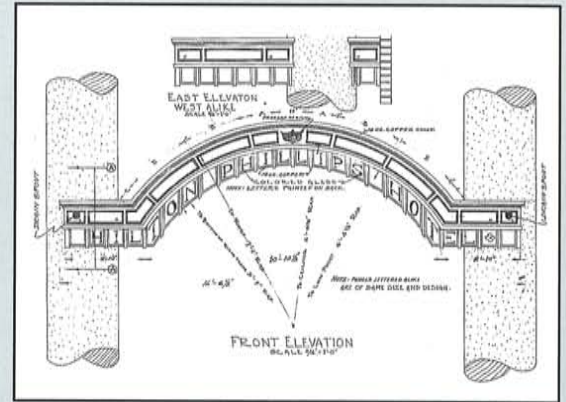
Figure 4. Original drawing for the main south entrance canopy for the Hilton Philips Hotel, later named the Aldridge Hotel. Note the lettering along the front glass panes. Drawing: Courtesy of the Hill Firm.

To install the new panes, a bead of clear silicone sealant was applied in the top and bottom of the metal frame, helping to secure the glass and prevent it from rattling in heavy winds. The glass was then slid into the top receiver and set into the bottom. The side tabs located on the back of the pendant frame were folded over to secure the glass. Since the original drawings showed the building's name painted on the back of the glass panes, this signage was recreated with the current name, the Aldridge Hotel (see figure 4).

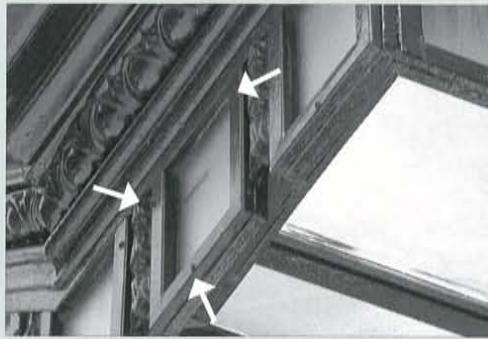
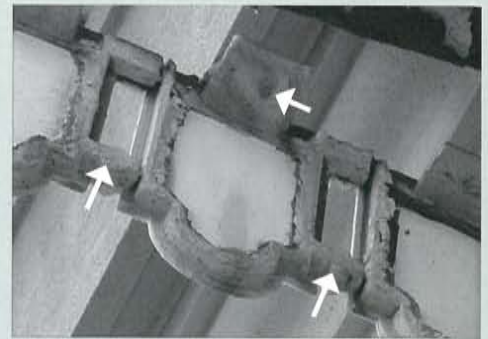
With the simple double-faced pendant frames on the left, the front and back faces are screwed directly to each other as indicated by arrows. The pendants on the right are single faced with the glass held in place by putty. Each pendant is secured to the top of the canopy and to adjacent pendants. Screw connections are indicated by arrows.
