Preservation Tech Notes

NUMBER 21

Replacement Wood Sash Utilizing True Divided Lights and An Interior Piggyback Energy Panel

BEATTY'S MILL (CORAL STREET ARTS HOUSE) Philadelphia, Pennsylvania

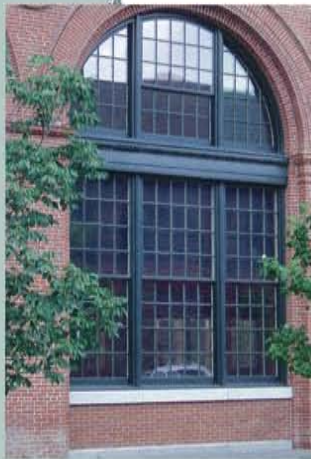
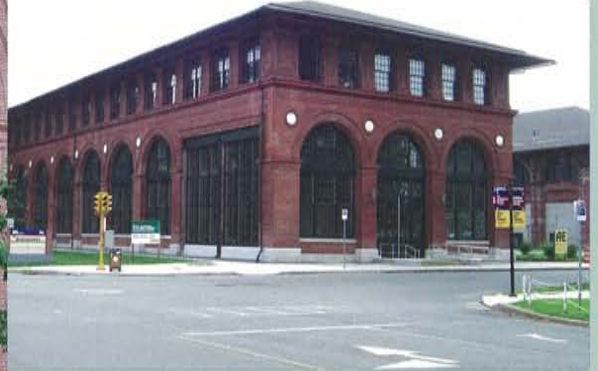
Figure A. Building 10 (headquarters of Urban Outfitters), former Philadelphia Naval Shipyard. New wood windows were made to match the original units, including true divided-lights, while incorporating a piggyback interior energy panel. Photos: Seaquay Architectural Millwork.

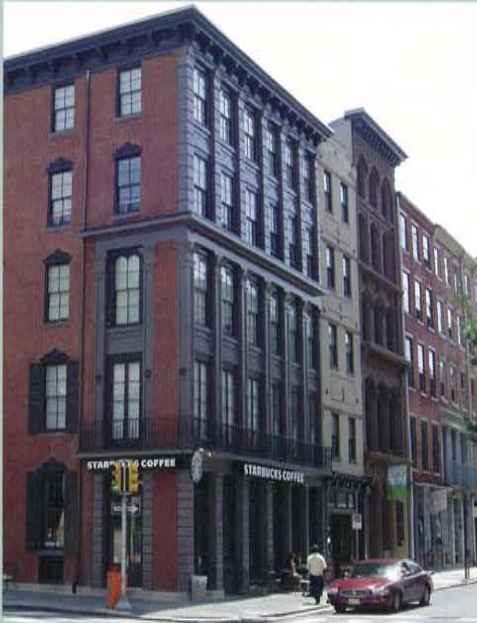
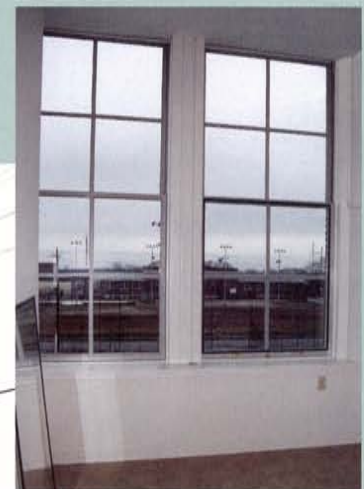
Figure B. 61-63 North Arch Street, Philadelphia (commercial and residential). Most of the historic windows were missing or severely deteriorated prior to the rehabilitation of this corner building. Based on surviving units, new non-clad wood windows were milled with matching true divided lights and piggyback energy panels. Photo: NPS file.

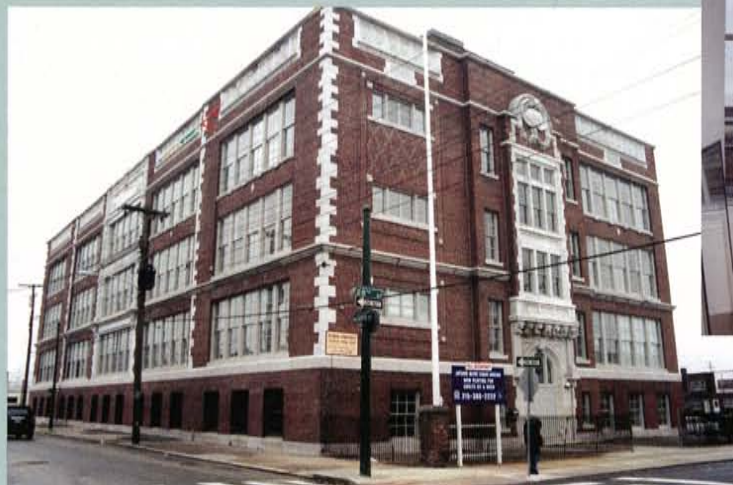
Figure C. Anthony Wayne School (affordable senior housing), former Philadelphia school. The predominant window type is a wood unit with four-over-four glass lights as shown in the lower right-hand photograph. The replicated wood window on the right is shown with the energy panels installed, while both sash in the left window have yet to receive the panels shown in the left forefront.
