Preservation Tech Notes

WINDOWS NUMBER 22

Maintenance and Repair of Historic Aluminum Windows

Kaaren R. Staveteig
Technical Preservation Services
National Park Service

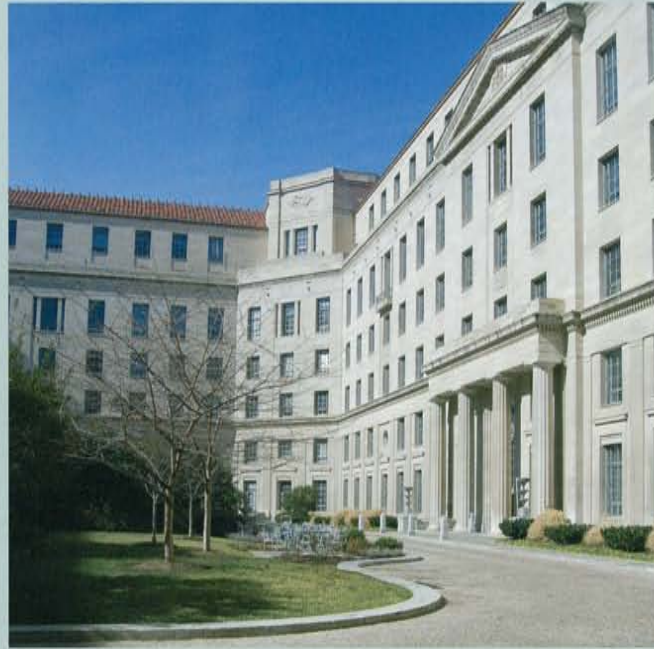
Figure a. In the primary courtyard within the U.S. Department of Justice Building, the aluminum windows emulate the appearance of steel windows with true divided lights. Depending on the floor level and location, the windows differ in size and consist of a varying combination of fixed lights, casements, and a hopper-style unit.

A window survey was first undertaken to record the condition of each window and to inventory the hardware, fasteners, and missing frame pieces. Although the windows retained a high degree of historic integrity, some changes had been made over the years. To allow for the installation of ventilation louvers or window-mounted air conditioning units, over 400 of the hoppers below the casements had either been removed or had been rendered inoperable and the wide vertical muntin removed. Although the historic windows were not designed for weatherstripping, some of the windows had been retrofitted with weatherstripping to reduce air infiltration as a result of worn hardware or deflections in the operable units. At various times, caulk had been applied to set in replacement glass or to fill in unwanted gaps. Areas of surface deterioration were also evident including discoloration and varying degrees of corrosion and pitting.

The renovation plan called for cleaning the aluminum window parts, replacing the existing glass and any missing or damaged parts, and making the historic windows fully operable again. Mock-ups of all phases of the work were required early on to establish the work standard to which the finished job would be held. It was anticipated that most of the work could be done in place, with work on the interior and exterior portions of each window done simultaneously.

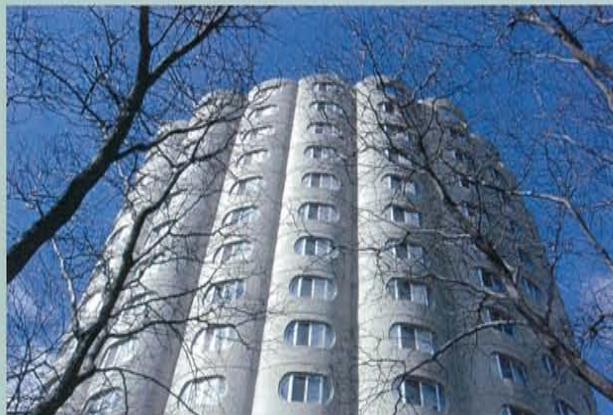
Figure a. One of two identical 16-story senior citizen apartment buildings within the Raymond M. Hilliard Center, each with 182 apartment units. The window openings are elliptical in shape and center on each reeded bay. (Photo: Holsten Real Estate Development Corp.)

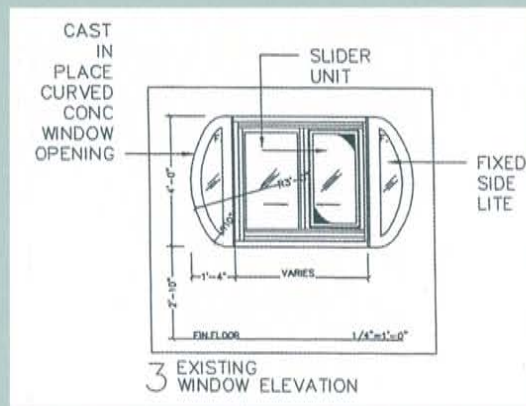
Figure b

completed a condition survey of 120 typical windows and found that 61% of the windows lacked the original glazing (replaced with Plexiglas or similar material), 31% had damaged operating sash, 29% were boarded up with damage to the frame, 25% were missing their original operating glazing sash, and 71% were missing screens. Only 15% of the windows had no visible defects.

The decision was made to save the historic windows for the first four floors of the towers, since they would be most visible from the ground. Units on the first four floors in bad condition were to be replaced by windows in better condition relocated from above floors. Matching aluminum replacement windows were to be installed on the upper floors.

The window survey provided an overall view of the necessary repair work to the historic units. There were standard components within each of the different window types and the aluminum had proved durable where not abused. Thus it would not be necessary to replace large numbers of the entire window assembly within each bay on the lower floors. The windows could be repaired, utilizing parts easily salvaged from other units within a building to replace worn-out or missing ones. In the total project, 336 original windows were to be repaired and 2,016 to be replaced.

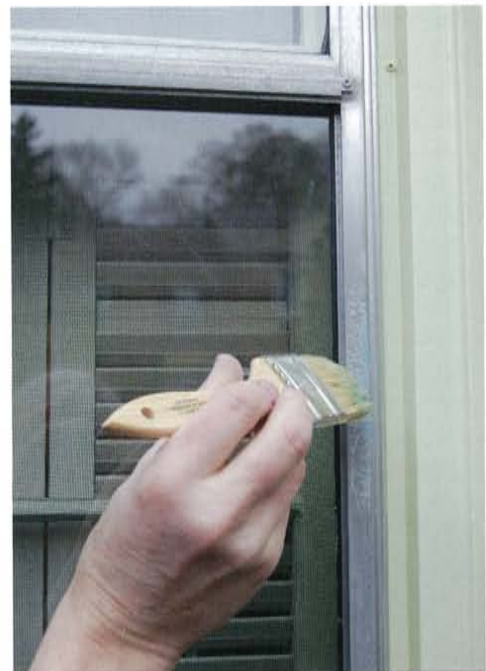
Figure 12. Cleaning tests may include a variety of products and methods such as mild soaps and detergents, etching cleaners, and abrasives. The gentlest means possible should be used, understanding that the goal is not to create a like-new appearance but rather to remove excessive grime and surface pollutants. Use of heavy etching cleaners or heavy-duty abrasives should be avoided on certain historic finishes. In this photograph a mild etching cleaner in jell form is being tested on a storm window with a mill finish.

Spot tests should always be performed beforehand to determine the suitability of any application to an existing finish. Regardless of the type and strength of any required cleaner or its form of application, it is important that all cleaned surfaces be thoroughly rinsed and wiped dry.

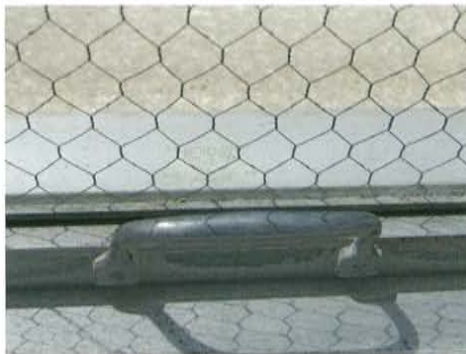
Figure 14. Hardware for early aluminum windows came in a variety of materials including steel, bronze, and nickel. Specialty hardware manufacturers can easily replicate suitable replacements today, matching the originals in both material and finish. The manufacturer's stamp, visible through the glass on the exterior sill of this window at the Folger Shakespeare Library in Washington DC, identifies Wm. H. Jackson Company of New York as the maker and dates the window patent to 1926.
