COLORADO STATE REGISTER OF HISTORIC PROPERTIES NOMINATION FORM

Historic Name Deatherage/Gibbs Place

Property Name Deatherage/Gibbs Place

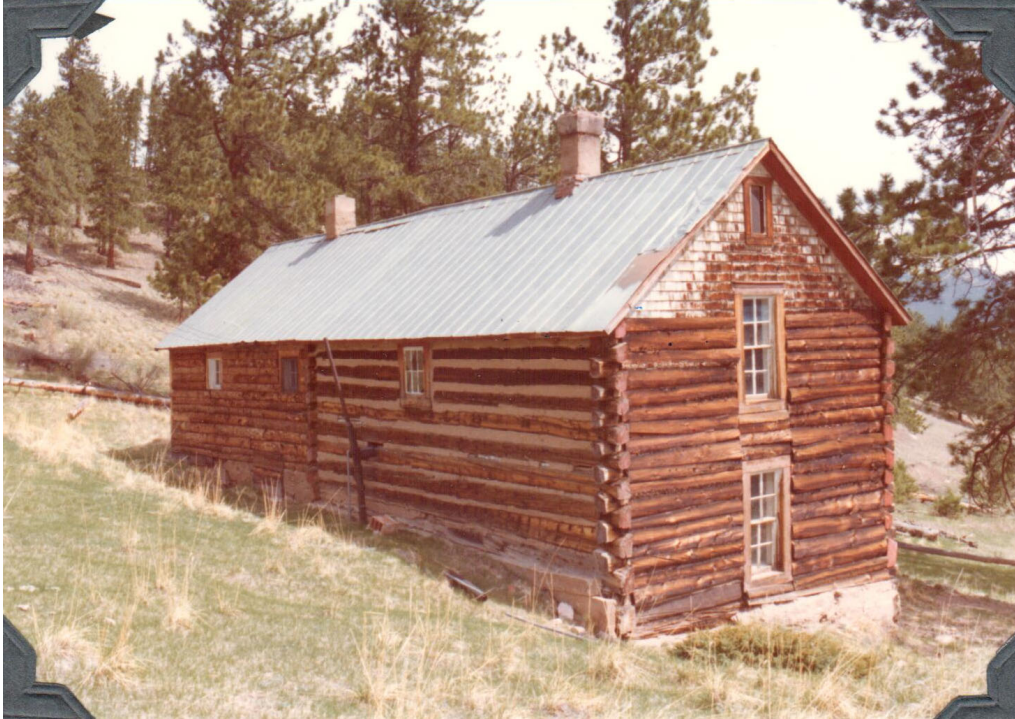
Photo HP1. Main House, view to the north showing south and west façades, 1979 (Dargan 1979).

The wood framed gable roof is covered with standing-seam metal roofing across both bays, although it is now missing at the northern two-thirds of the west side of the building, and at an area on the south end of the west side, exposing the wood boards that cover the gable frame. Chimneys, now mostly destroyed, project through the ridgeline at the center of each bay. As previously documented in the 1989 report (Horn and Mead 1989), the chimney in the north bay was poured-concrete and the chimney in the south bay was brick. Historic photograph #HP1 (Dargan 1979) shows that the brick was surfaced with a rendering material.

The south side of the building has a window opening centered on the ground floor, with another opening directly above this on the upper level that extends into the gable end. Historic Photo #1 (Dargan 1979:17-18) indicates that both windows were four-over-four double-hung wood sash windows. A smaller window opening, previously noted as a single-pane casement window, is located above within the gable end near the peak (Horn and Mead 1989).

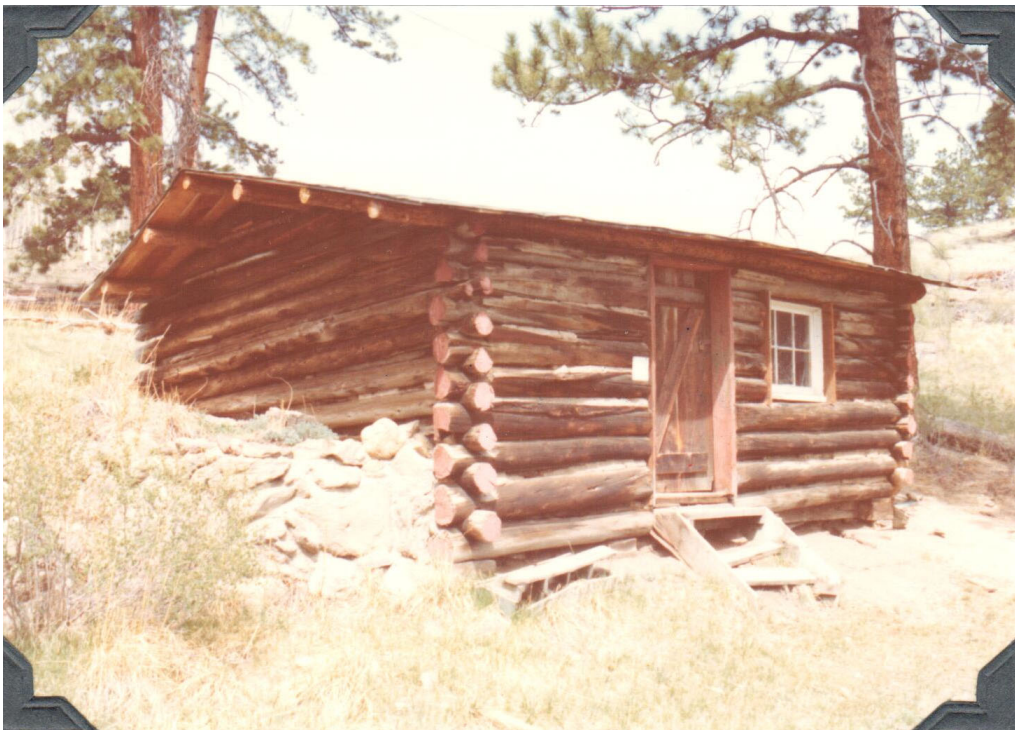
Photo HP2. Workshop, view to the northwest, showing the south and east façades (Dargan 1979).

The workshop (Resource 2) is located 12’ northwest of the house, but today it is completely collapsed, with the roof lying on the ground and the remains of the building components underneath. The date of construction is difficult to state exactly, for the reasons outlined above, but the log construction suggests it was built in the same period as the house, although the log construction materials and techniques are different.

The workshop was a one-story rectangular log building. Previous recording of this building when it was standing (Horn and Mead 1989) describe it as “a 14 by 20 foot log and wood frame building, oriented north to south, built into the east facing slope. The building has a simple gable roof, framed with newer unpeeled logs, and is covered with green composition shingles. The foundation is of sawn block piers. Log walls are present only on three sides. The west side is wood frame set in from the side walls about a foot and faced on the exterior with half-round mill ends set vertically. At the southeast and northeast corners, where log walls come together, both saddle and V-notches are used. No notches are present at the southwest and northwest corners. Mud chinking [daub] between the logs is held in place by wood strip ledges nailed to the logs. The building appears to have been constructed from logs from an earlier log cabin. The only entry into the building is through a doorway located just south of center in the east side. A set of wooden steps lead up to the plain board door. Just to the right of the door is a six light, wood sash, casement window hinged on one side. No door or window openings are located in the north or south sides. A fixed sash window is located on the north end of the west side. This is made of four sashes of six over six double hung windows set end to end horizontally. The door and window openings are presently covered with plywood for protection. The interior of the workshop is floored with 1 by 10 inch boards. A work bench runs all along the west wall and a homemade table is located in the northeast corner. A shelf has been installed on the south end of the east wall. At one time the building was equipped with electricity.”

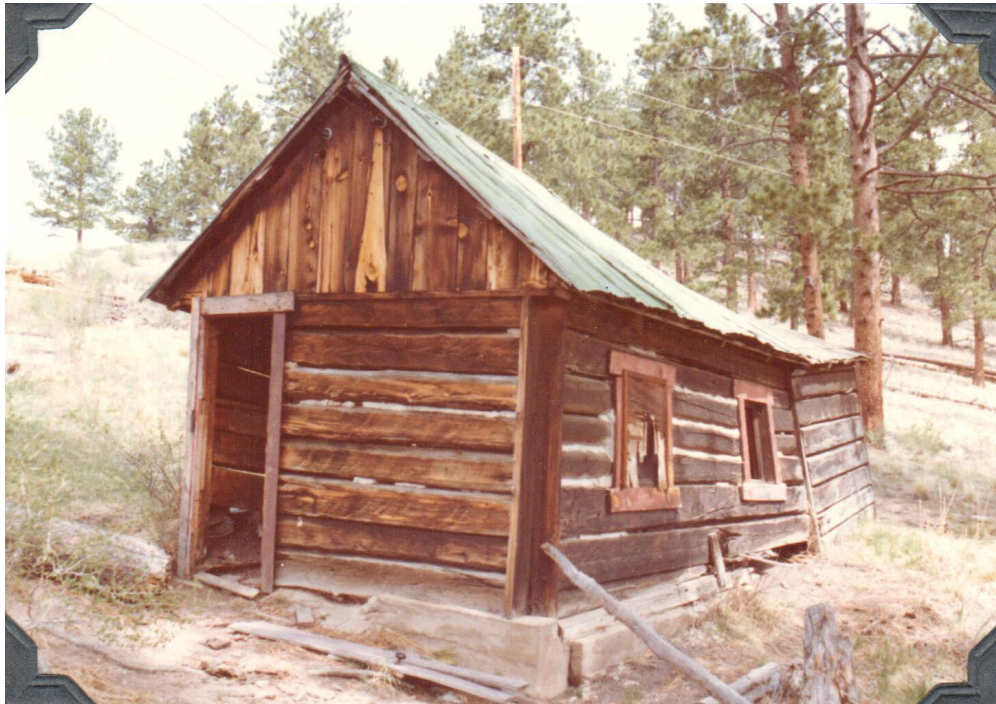
Photo HP3. Generator House, view to the northwest, showing the south and east façades, (Dargan 1979).

What has been dubbed the ‘Generator House’ (Resource 3) is located 20’ north of the Workshop. The apparently original south bay is a one-story 10’ x 18’ rectangular log building with a front-gable roof, which has a 10’ x 12’ log addition on the north end. The north and west walls of this addition are now missing, and the south bay leans towards the west. Again the date of construction is difficult to state exactly, for the reasons

The older south bay of the building is set on a partial concrete foundation on the south side. The south end of the east side the foundation appears to have been added after the walls were in place. The northern log addition was built directly on the ground. As it exists today, and previously described, “the building is made of logs adzed flat inside and out but not notched together. The ends of the logs are sawn off flat and held together by [corner] boards nailed down their length. Chinking [daub] is a combination of concrete, mud, and wood wedges nailed in place” (Horn and Mead 1989). The north bay, although partially collapsed, was similarly constructed. Horn and Mead noted that the logs used to build the Generator House appeared to have come from an older building and cut to length. Evidence of re-use of logs comes from the presence of broken square nails in some of them. Only round nails seem to have been used in the construction of the generator house. The roof on the original portion of the building is a wood framed gable covered with standing seam metal roofing material, painted green. On the east side this metal roof overlays wood shake shingles which are visible at the edges. Vertical boards fill gable ends and electrical ports are visible high in the south gable. The roof on the north addition is largely missing, but the roofline can be discerned where it was attached to the north end of the original building. It does not match the roofline of the south building, as it is not as high and is somewhat offset to the east. A collapsed ridge-beam has six panels of two overlapped pressed-metal ridge cap shingles intact, with remnants of green paint on the shingles (photo 18).

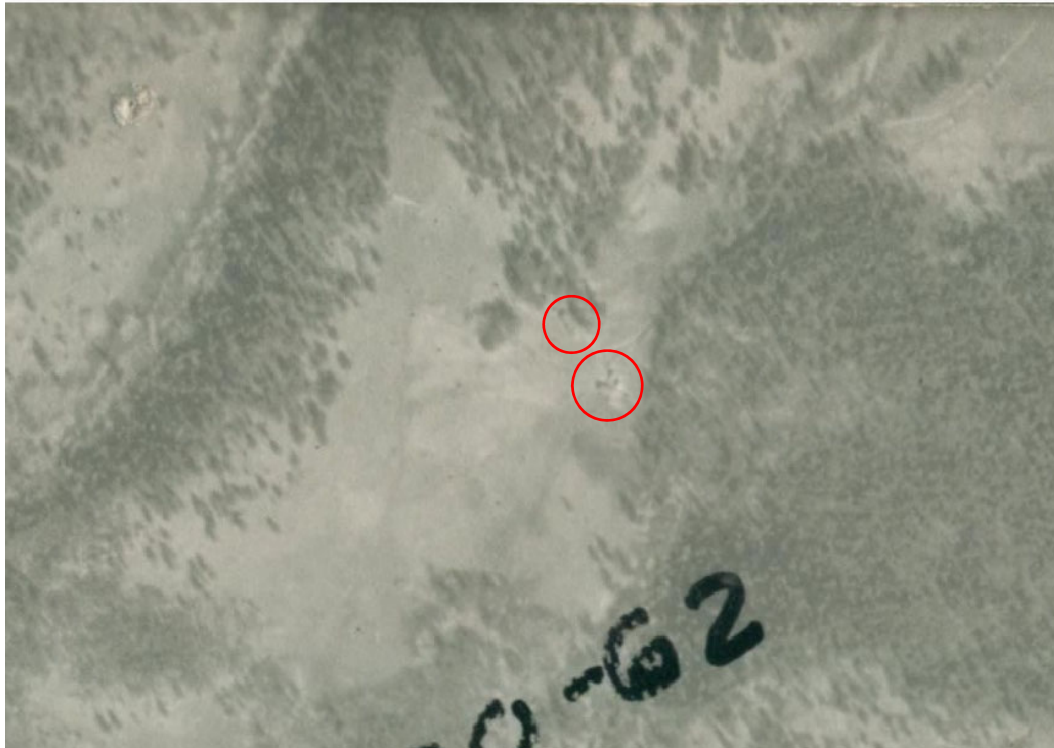
Photo HP4. Aerial Photo showing the Main House (top red circle) and the now-demolished barn and outbuildings (bottom red circle) (Aerial Photos of Colorado, 1938 Image Number BOV39.65).

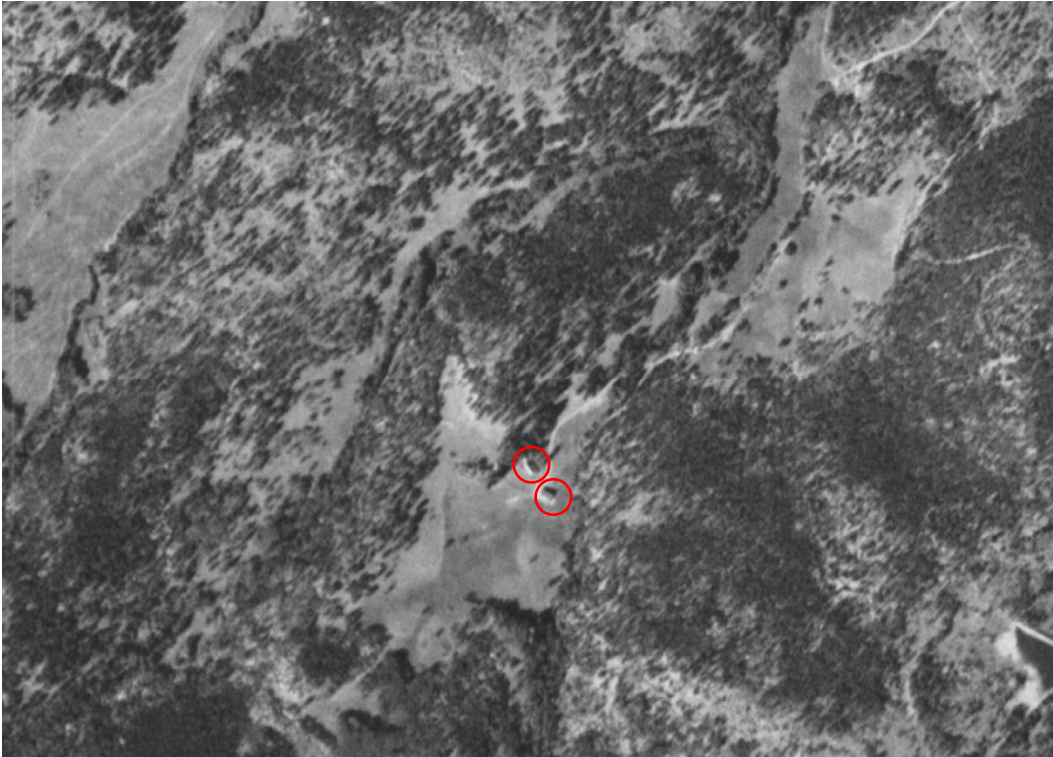
Photo HP5. Main House (top red circle), and the now-demolished Wilson's House (bottom red circle) aerial view (Aerial Photos of Colorado, 1953 File Number A001260736635.tif).
