WEEKLY LIST OF ACTIONS TAKEN ON PROPERTIES: 10/06/08 THROUGH
10/10/08

United States Department of the Interior National Park Service National Register of Historic Places Registration Form

historic name Heister House

**National Register of Historic Places
Continuation Sheet****United States Department of the Interior
National Park Service**Heister House
Chaffee County/ ColoradoSection number 7 Page 1**DESCRIPTION**

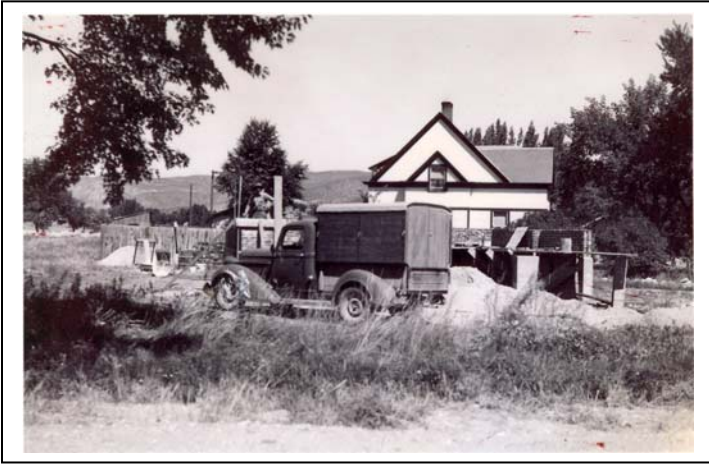
Photo H1- South facade, brick structure seen at west end. Date unknown.

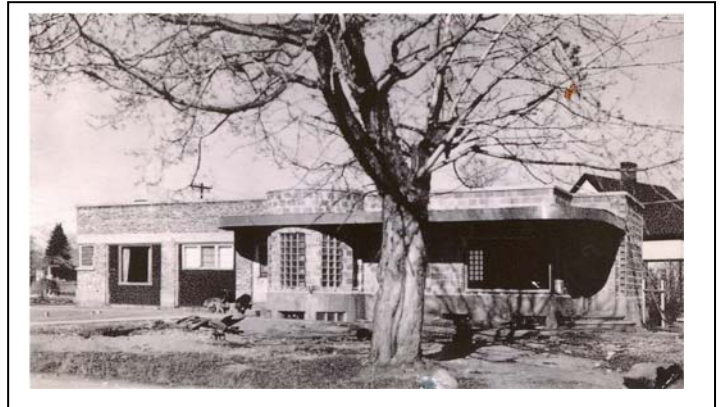
Photo H2- South elevation, brick & block structure waiting for stucco. Window in brick section yet to be placed. Date Unknown.

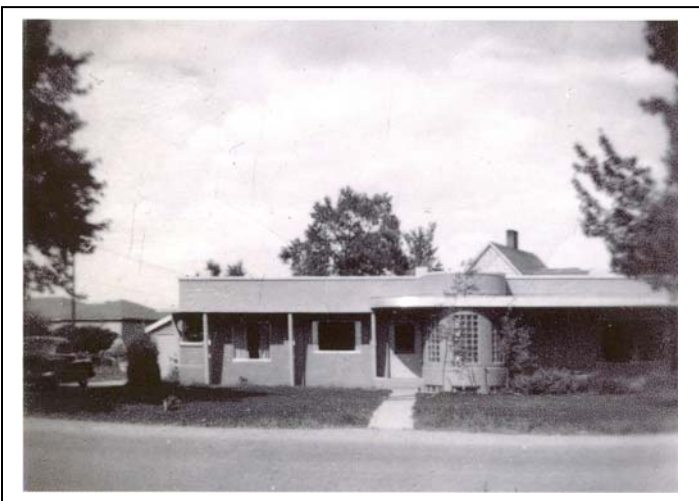
Photo H3- House in 1954. Interior yet to be completed.

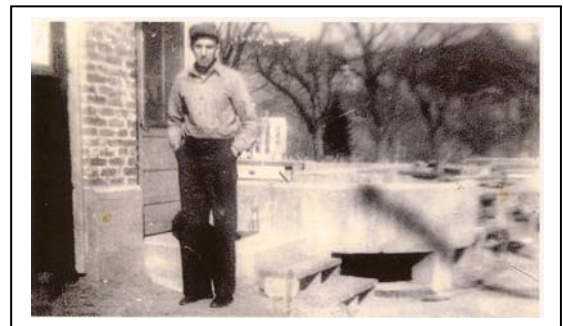
Photo H4- Elwood Heister at south secondary entry- basement started. Date unknown, probably 1942-43.
