# National Register of Historic Places Registration Form

historic name Nachtrieb/Kelly Ranch

other names/site number Maxwell Ranch/5CF.2876

state Colorado code CO county Chaffee code 015 zip code 81211

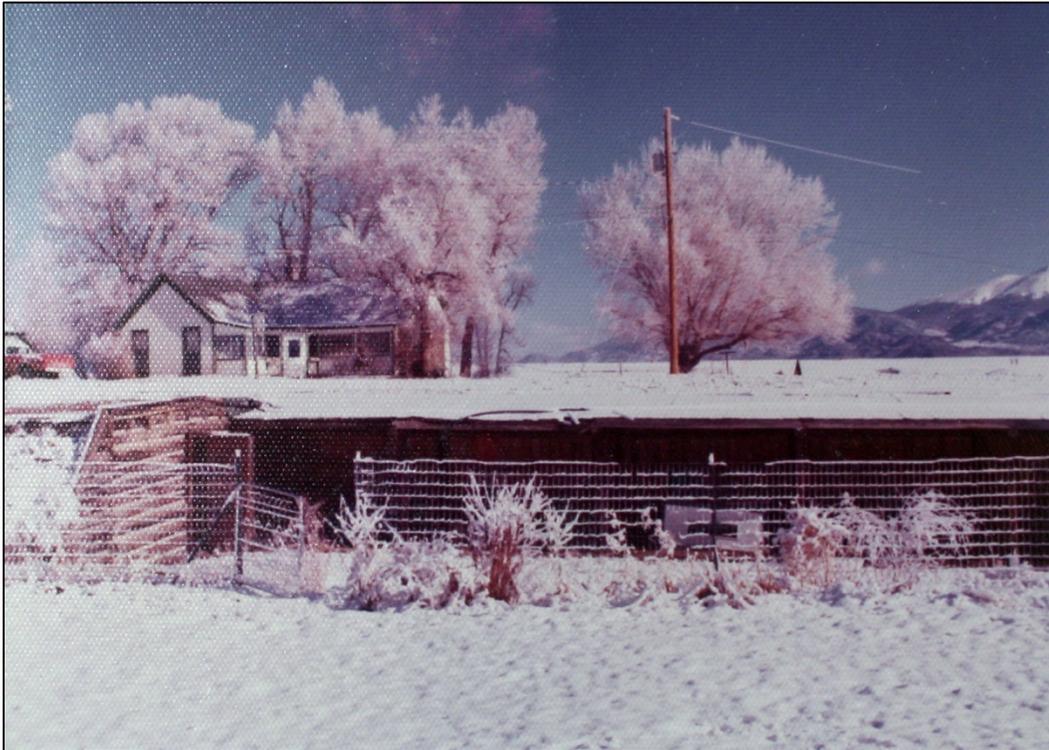
Figure 2. This 1973 view (north-northwest) from the yard of the southern house shows two of the outbuildings (Resources 7 and 8, left and right) built into the slope in the foreground and the homestead house (Resource 2) in the upper left. Courtesy of Bryce and Suzy Kelly, Buena Vista, Colorado.

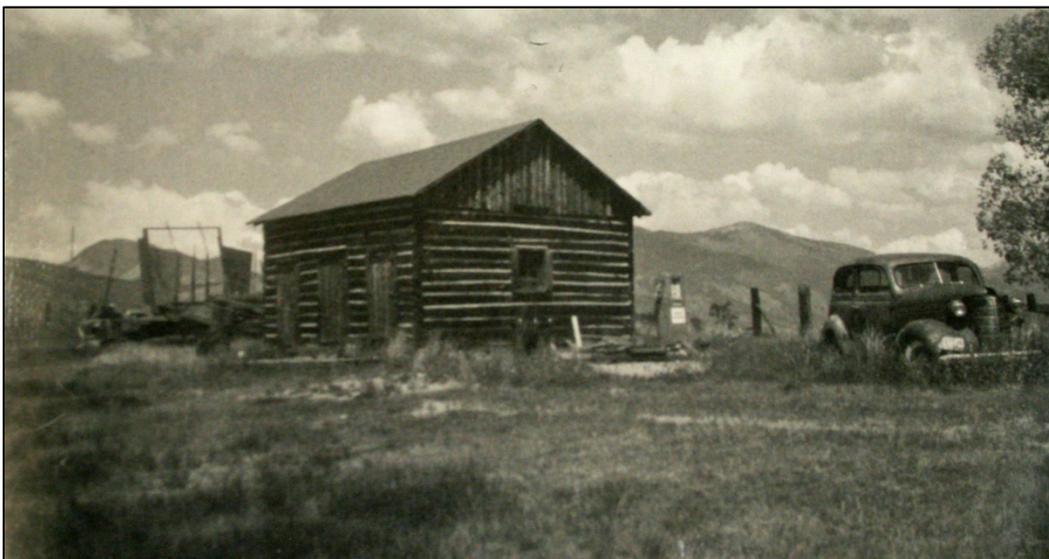
Figure 3. The granary (Resource 6) is shown in this ca. 1970s-80s assessor card photograph (view west-northwest). Courtesy of Chaffee County Assessor, old real property appraisal card, Salida, Colorado.

During the Kelly era the granary was used to store cottonseed meal and cake, molasses, and fertilizer (see Figure 3). The one-and-a-half-story side gabled roof granary (21' x 17') is located southeast of the large utility shed (Resource 14). Partitions divide the interior into three sections. The building faces south, has a concrete-clad stone foundation, and features square hewn log walls with daubing that are joined at the corners with V notches. The front wall contains three vertical board doors with strap hinges facing a raised board deck extending the length of the wall. The west wall has a central square window opening (boarded-up) with a plain wood surround; farm tools are attached to the west wall. The north wall is unfenestrated. The east wall contains a center wood four-light window (boarded-up on the interior) with a plain wood surround. Two metal gasoline signs are displayed on the east wall: Champlin Gasoline and Mobilgas. The gable faces are clad with slab logs and the east gable face contains a slab log hayloft door. The roof is clad with standing-seam metal roofing and has overhanging eaves. *Alterations:* Windows are boarded up and the granary had metal roofing installed in 2000.

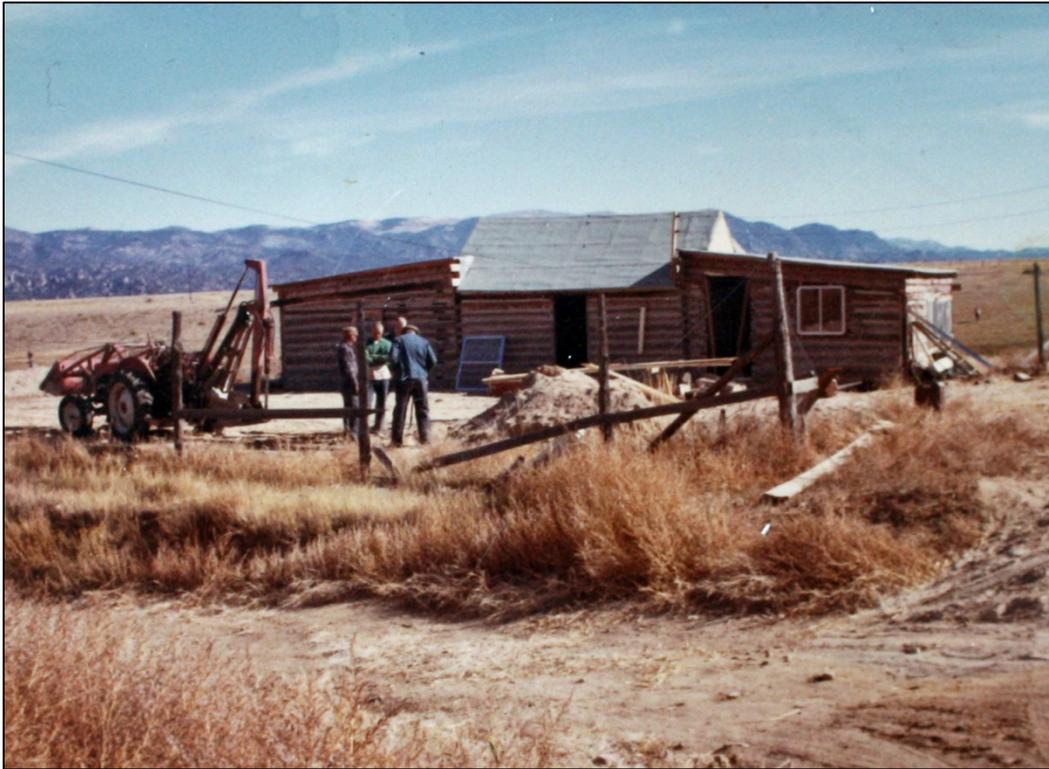
Figure 4. This ca. August 1966 photograph (view southeast) shows the former bunkhouse, used then as a chicken coop, that Bryce and Suzy Kelly remodeled and expanded into their current home (Resource 12; see next figure). Courtesy of Bryce and Suzy Kelly, Buena Vista, Colorado.

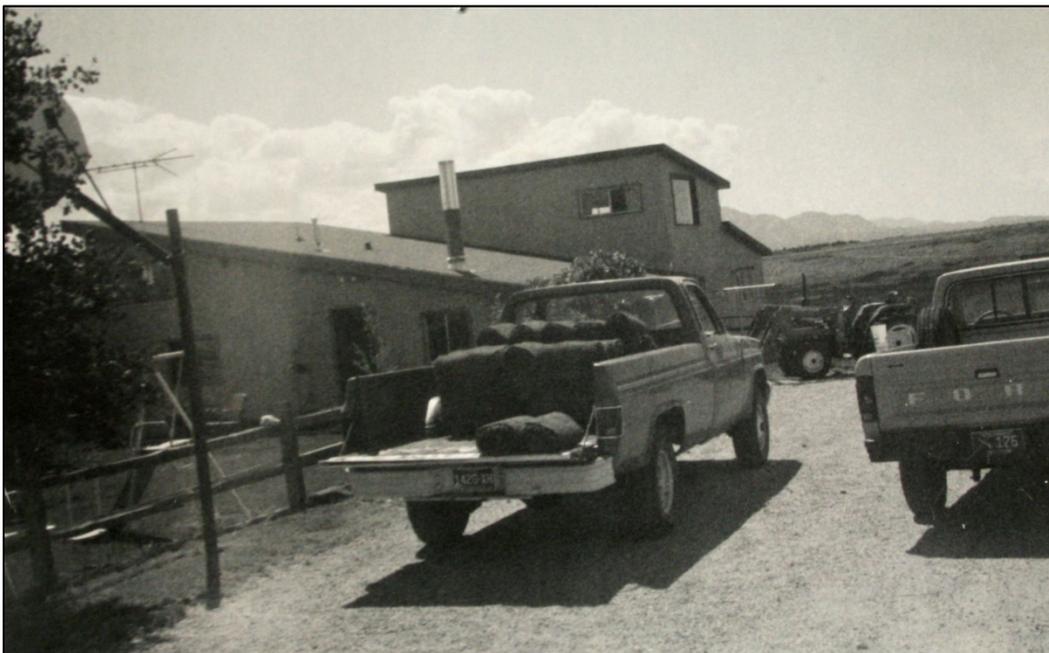
Figure 5. The former bunkhouse took on a new look after Bryce and Suzy Kelly's remodeling and expansion, as shown in this ca. 1970s-80s assessor card photograph (view southeast) (Resource 12). Courtesy of Chaffee County Assessor, old real property appraisal card, Salida, Colorado.

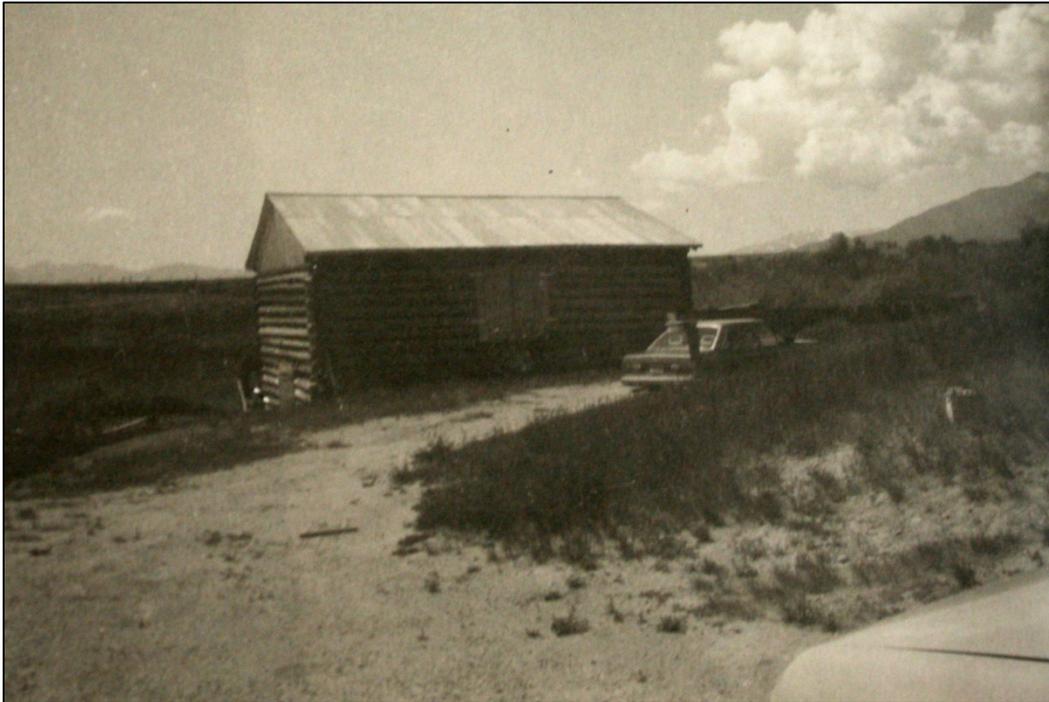
Figure 6. The bank barn (Resource 10) at the south end of the headquarters had a somewhat steeper roofline, as shown in this ca. 1970s-80s assessor card photograph (view south-southwest). After storm damage the roof was rebuilt with its current, shallower slope. Courtesy of Chaffee County Assessor, old real property appraisal card, Salida, Colorado.

Southwest of the new ranch house is this two-story log bank barn (31' x 30') built into the slope of the land to the north (see Figure 6). The foundation is stone. The walls are composed of round logs with daubing and are joined at corners with full dovetail notches; the log ends project slightly at corners. The east wall contains a center double door entrance on the first story; doors are two-part vertical board doors with diagonal bracing (the lower part of the north door is missing). The upper story is blank. The south wall features three small square one- and two-light windows with plain wood surrounds on the first story; the upper story is blank. Extending across the length of the south wall is a one-story open shed roof addition (date unknown) with log supports and ribbed metal panel roofing. The west wall is blank. The north wall contains center double plywood doors with a timber sill on the second story; the bottoms of the doors are about 4' above ground level. A portion of the first story is visible at the east end and is composed of roughly coursed stone. The barn roof is clad with corrugated metal roofing and has overhanging eaves and exposed rafter tails. *Alterations:* The full-width shed roof section on the south was added after 1963. The roof collapsed due to snow in 1973 and was replaced with a shallower pitch roof. The roof and gable faces were clad with standing seam metal panels in 2013. The double doors on the north wall are replacements made of plywood.

6 of 8, The bank barn (Resource 10) at the south end of the headquarters had a somewhat steeper roofline, as shown in this ca. 1970s-80s assessor card photograph (view south-southwest). After storm damage the roof was rebuilt with its current shallower slope. Courtesy of Chaffee County Assessor, old real property appraisal card, Salida, Colorado.

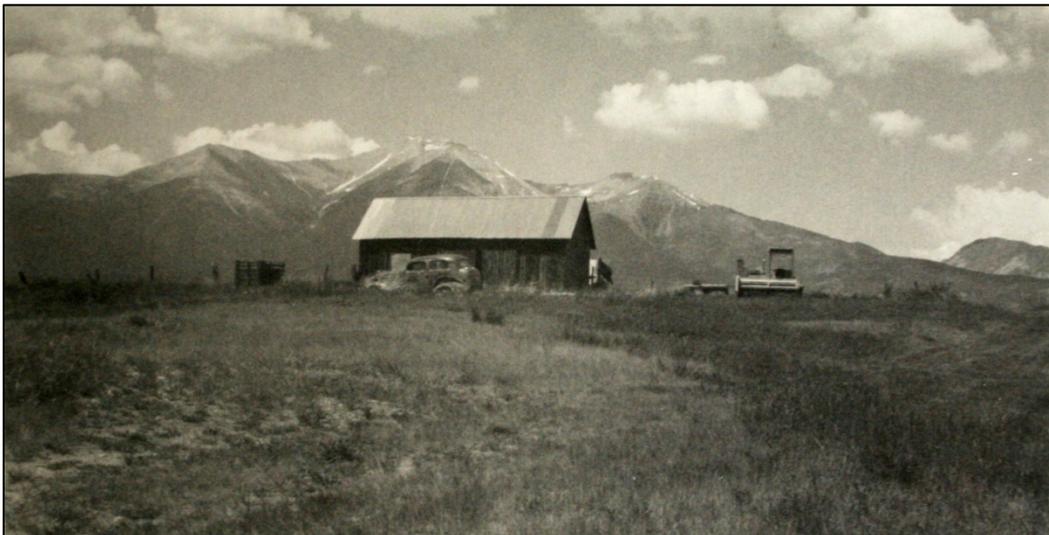
Figure 7. The blacksmith shop stood on the west edge of the headquarters until it was blown down by strong winds ca. 1996. Its concrete foundation remains. It is shown in this ca. 1970s-80s assessor card photograph (view west). Courtesy of Chaffee County Assessor, old real property appraisal card, Salida, Colorado.

The headquarters originally held a blacksmith shop (see Figure 7) until ca. 1996, when it was blown down by wind. The ruins of its concrete foundation (36' x 18') lie on the west edge of the headquarters about 142'

7 of 8, The blacksmith shop stood on the west edge of the headquarters until it was blown down by strong winds ca. 1996. Its concrete foundation remains. It is shown in this ca. 1970s-80s assessor card photograph (view west). Courtesy of Chaffee County Assessor, old real property appraisal card, Salida, Colorado.

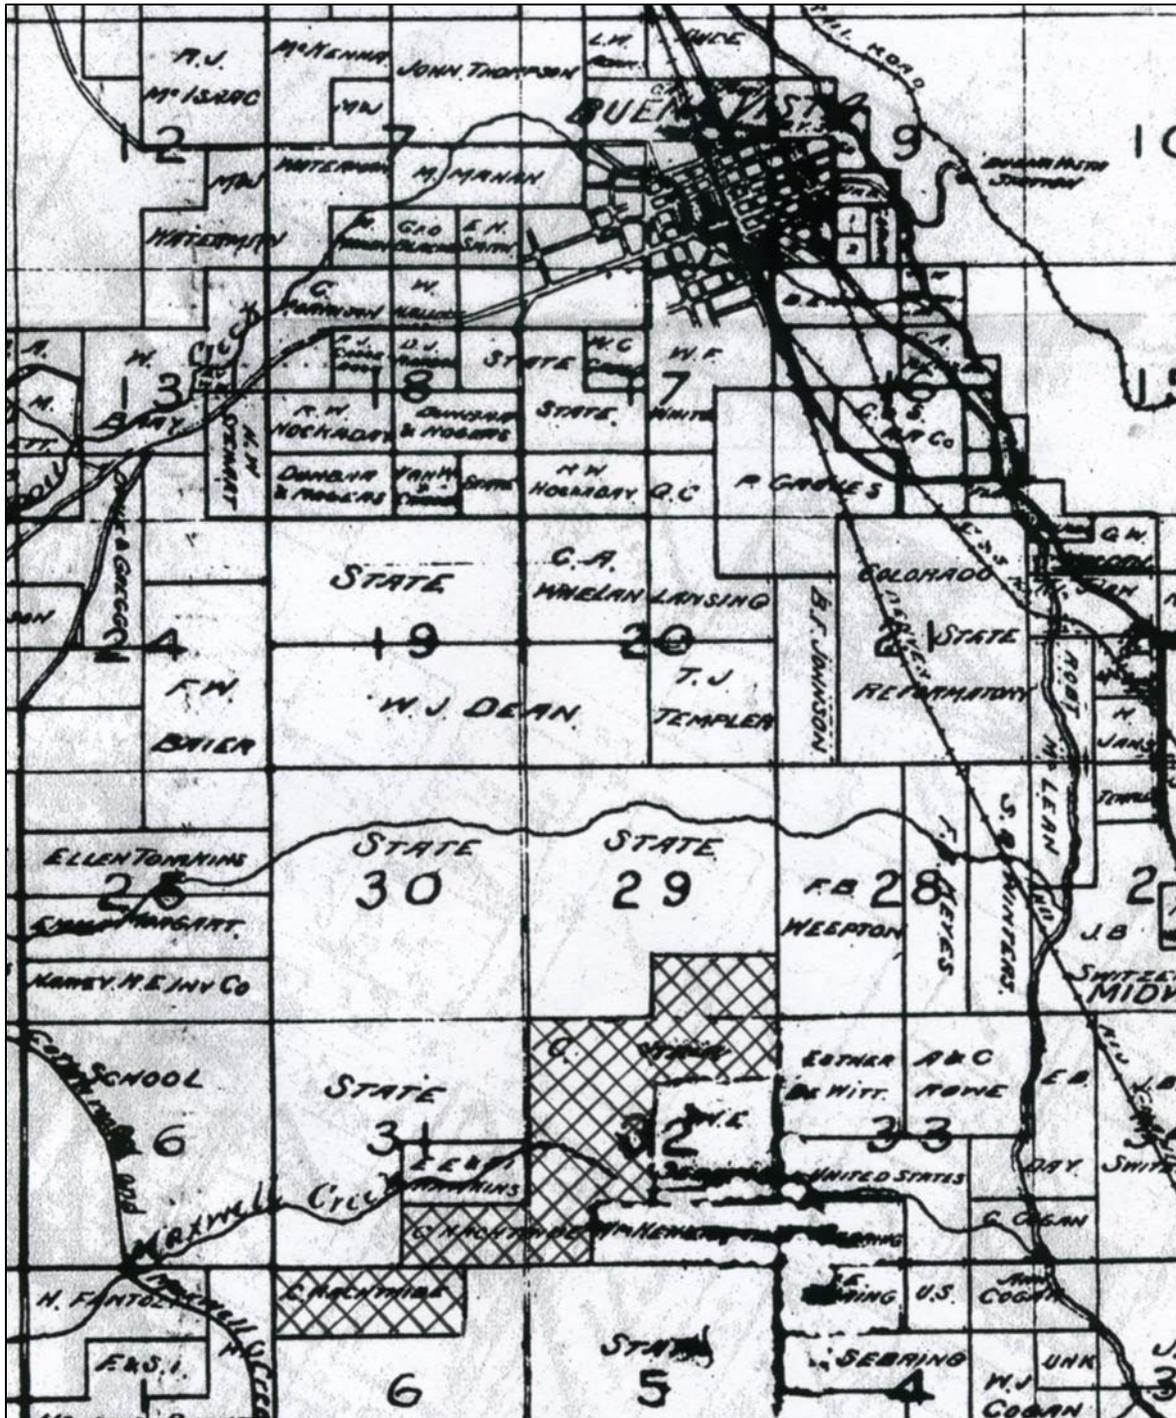
Figure 8. The Nachtrieb ranch (crosshatched) encompassed about 640 acres in the early 1900s. The original 160 acres obtained by a cash entry patent in 1876 is at the northeast corner. The Nachtriebs also acquired long-term leases on the state land abutting the ranch. Buena Vista is in the upper right of the map. Courtesy of Shaputis, *Where the Bodies Are in Central Chaffee County, Some Land Owners and Old Roads in Northern Chaffee County, ca. 1900-10*, map.
