National Register of Historic Places
Registration Form

historic name Rock Ledge Ranch/Franzel Ranch
other names/site number Wilber Homestead/5CF.2878

street & number 17975 County Road 338 N/A not for publication
city or town Buena Vista X vicinity
state Colorado Code CO county Chaffee code 015 zip code 81211

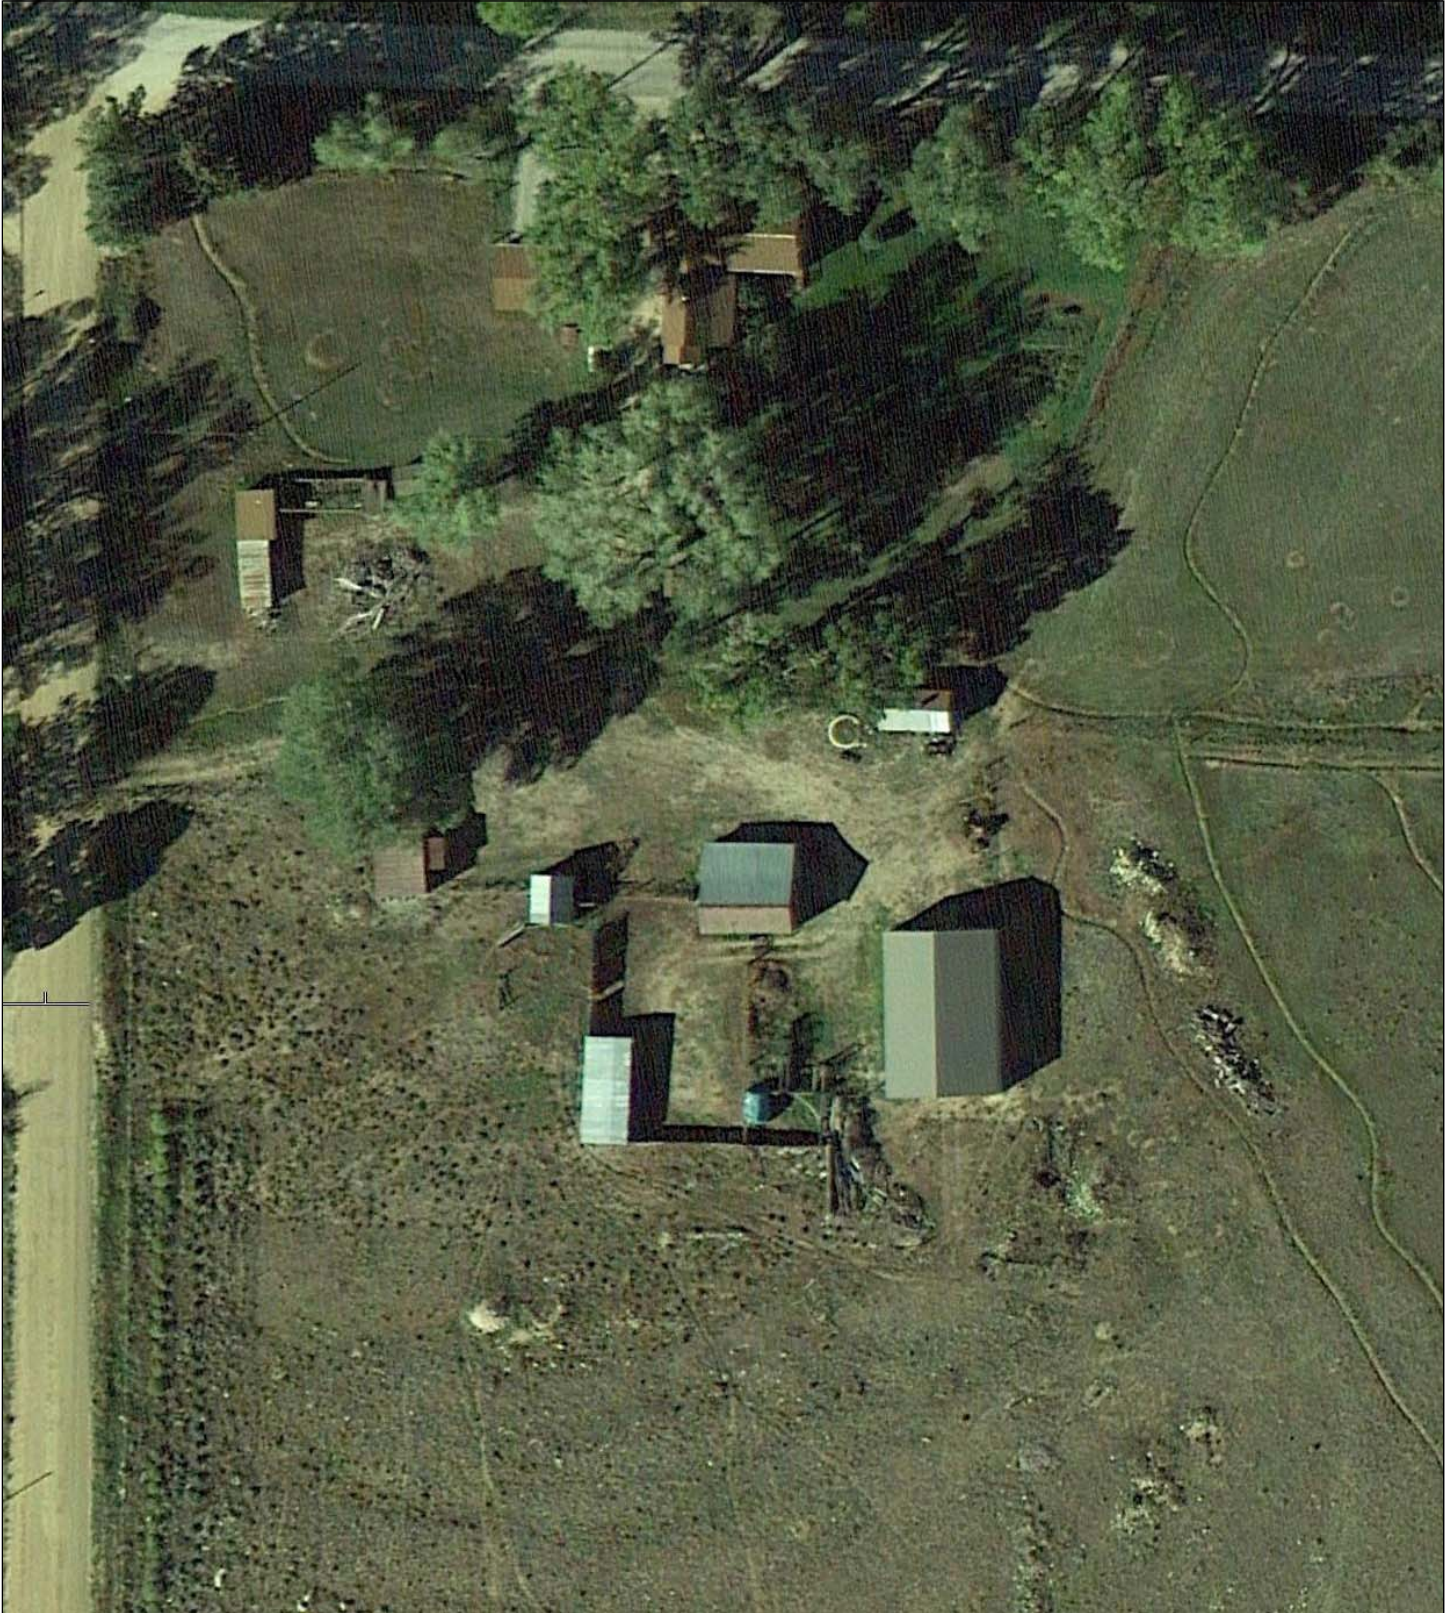
Figure 1. The Franzel Ranch headquarters is shown in this 2013 Google Earth image that generally covers the same area as the detailed Sketch Map. Courtesy of Google Earth, 23 September 2013.

Since 1887 this land has been the site of farming and ranching operations initiated by Ernest Wilber and continued by three generations of the Franzel family. The property is surrounded by agricultural lands, with Mount Princeton and its foothills to the southwest, the foothills and Mount Yale rising to the west, and more distant mountain ranges to the south and east creating magnificent scenic vistas (Photographs 1 through 4 and Figure 1).

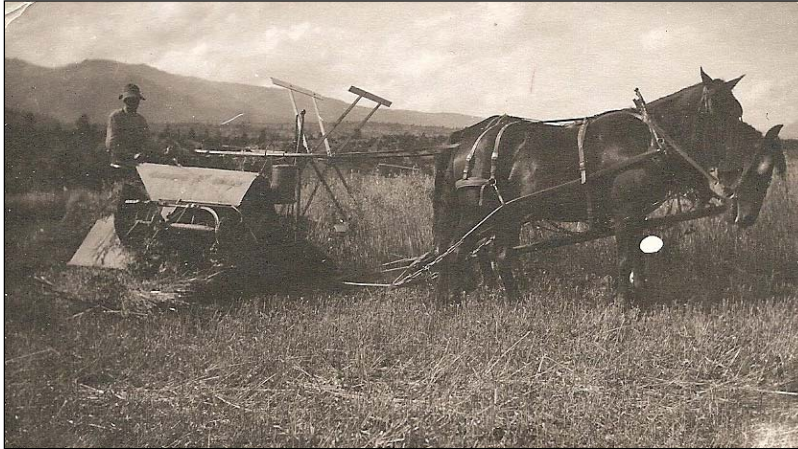
Figure 4. This undated photo (perhaps 1930s or 1940s) shows Carl Franzel harvesting a grain field with a horse team and grain binder. Courtesy of Buena Vista Heritage, Buena Vista, Colorado.

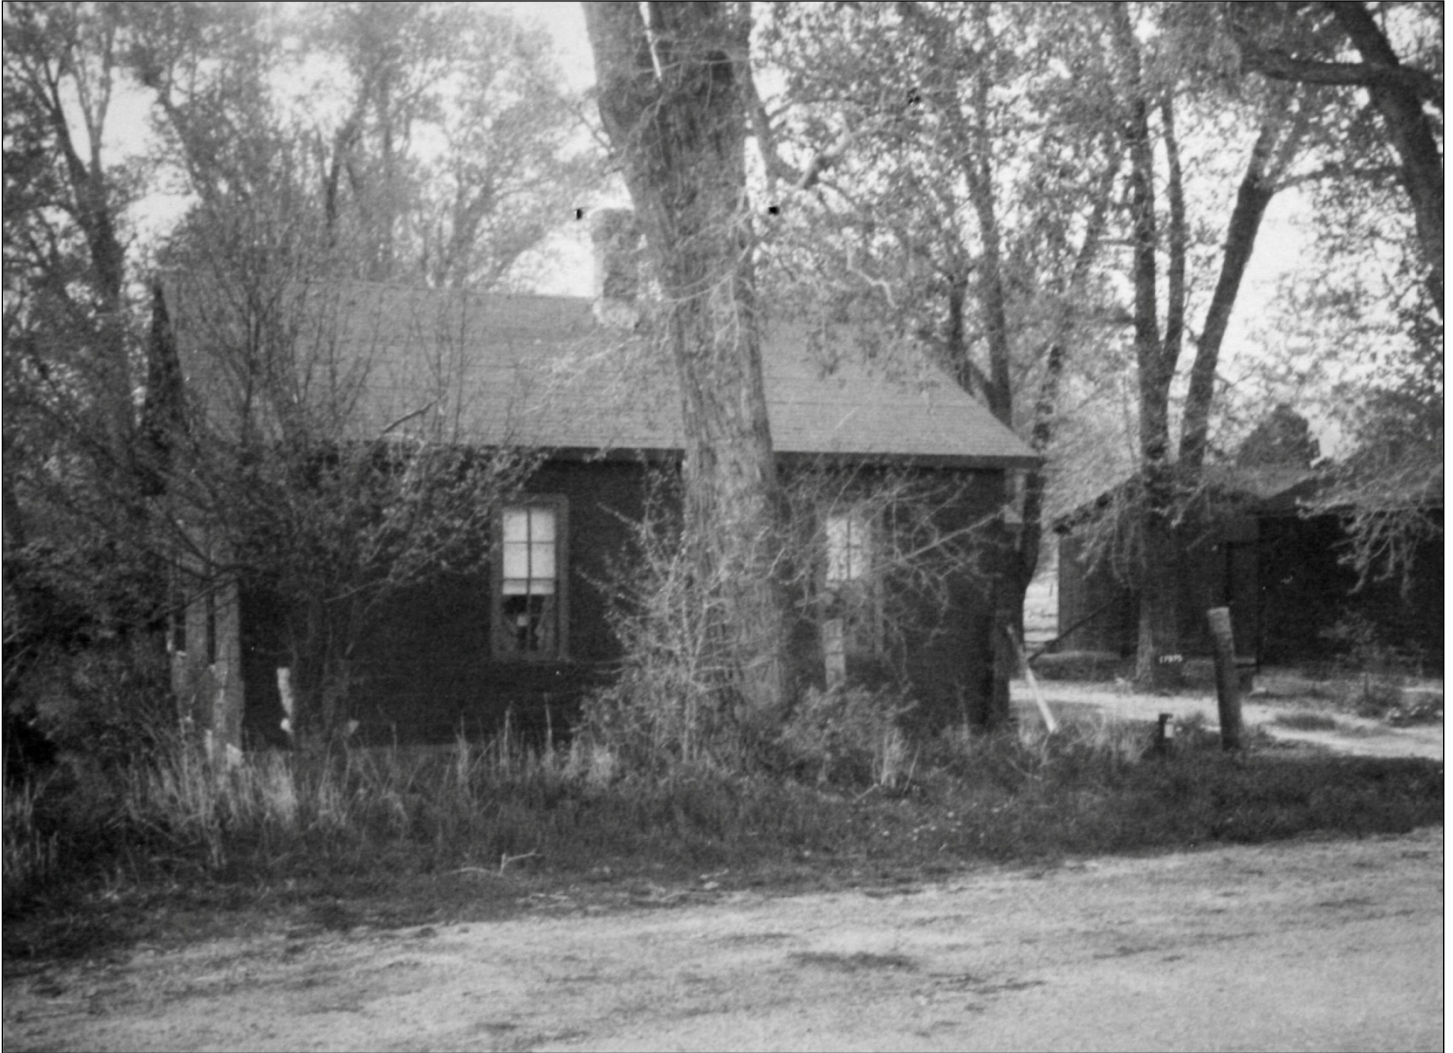
Figure 6. This 1970s-80s Assessor image (view southwest) shows the main house (Map Reference 14) and the entrance to the ranch from County Road 338 before the 1987 remodeling and expansion. Courtesy of Chaffee County Assessor, Salida, Colorado.

In his Homestead Proof testimony, Ernest Wilber reported building his log house about 1888. The one-story gabled roof L-shaped main house includes the original log homestead house and a 1927 rear addition that was moved in from Leadville. In 1987, the Franzels remodeled the dwelling, expanding the north wing eastward, re-siding and re-roofing it, and adding new doors and windows. The walls are clad with wood panels with vertical scoring. The north wall includes two six-over-six-light double-hung sash windows toward the east and two toward the west; the original log house is at the west end, with the windows in their original position. A small projecting side-gabled-roof enclosed porch with a paneled door facing a concrete stoop is on the west. Farther south is the 1927 wing that terminates with a slightly lower, gable-roofed, projecting enclosed porch. This building is evaluated as noncontributing due to expansion and remodeling resulting in loss of historic physical integrity.

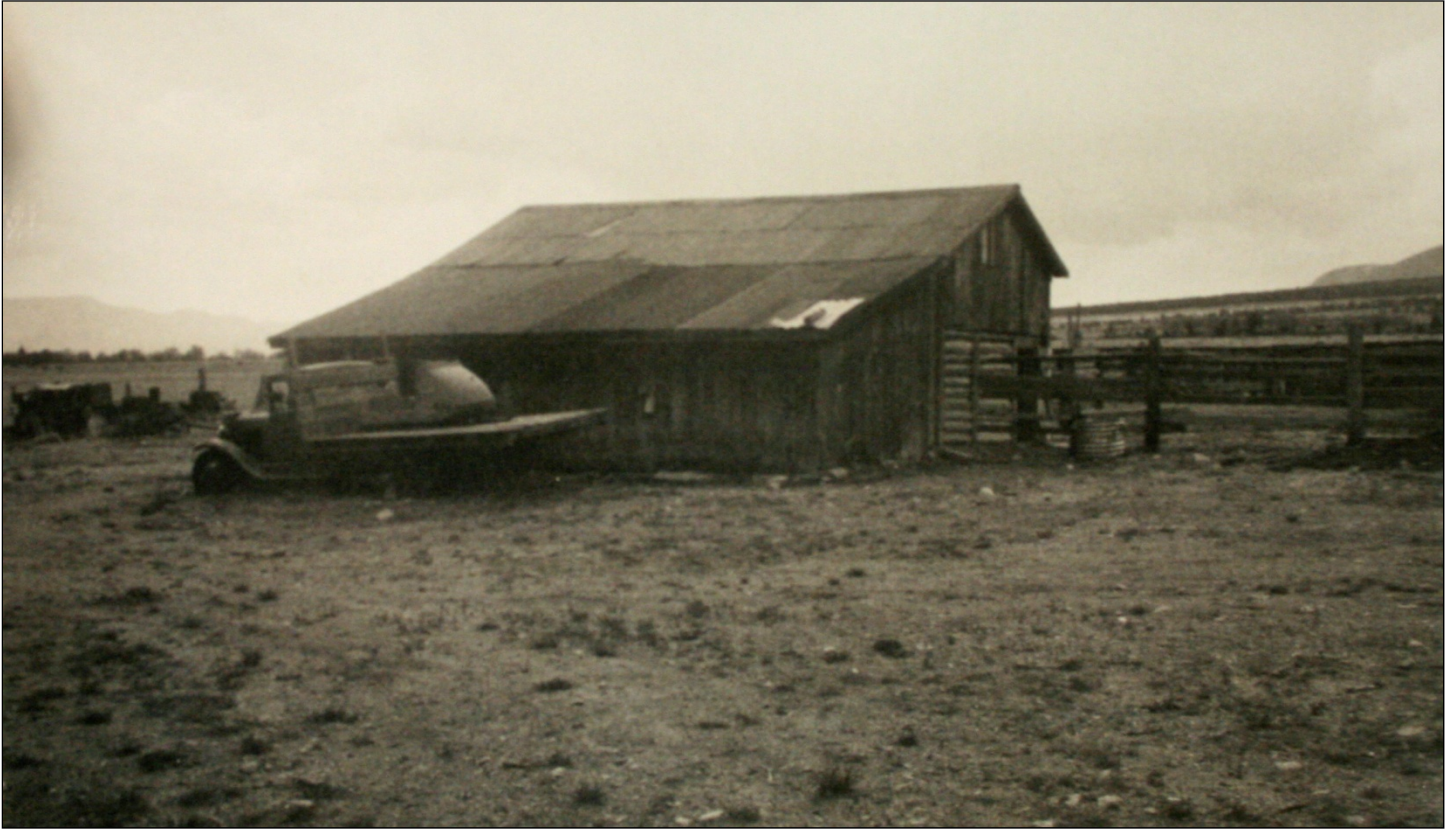
Figure 7. This 1970s-80s Assessor appraisal card photograph (view southeast) shows the north and west walls of the log barn (Map Reference 2) and part of the corral. Courtesy of Chaffee County Assessor, Salida, Colorado.

The rectangular (32' x 31') barn stands at the north end of the headquarters corral facing east. The gabled-roof building is oriented east-west, with the shed bay on the north wall. The foundation consists of stones gathered from the site and some added concrete. The walls of the barn are composed of round logs with daubing that

are joined with full dovetail notching; vertical planks cover the corners, except at the southeast. The walls above the logs are clad with vertical boards. The walls of the shed roof bay also display vertical boards. Cut and round wire nails are found on the building. The barn roof has overhanging eaves, corrugated metal roofing on the east slope, and standing seam metal roofing on the west; the shed bay is roofed with standing seam metal.

The north and west walls of the shed roof bay are clad with vertical boards. The north wall has no openings. The west wall of the shed bay near the center has a small opening with a vertical board door with strap hinges. The opening was used to insert grain. The west wall of the barn at the south end contains a vertical board pedestrian door illuminated by a metal goose neck light. The south wall of the barn, adjacent to the corral, contains a four-light window to the west and a two-light square window to the east, both with plain board surrounds. Between the two windows, a vertical plank extends from the foundation to the top of the wall in the location where two sections of logs meet.
