United States Department of the Interior National Park Service National Register of Historic Places Registration Form

historic name Hudson, Sim, Motor Company

other names/site number Golden Belt Garage; Vince's GM Center; 5KC.46

street & number 1332 Senter Ave. [N/A] not for publication

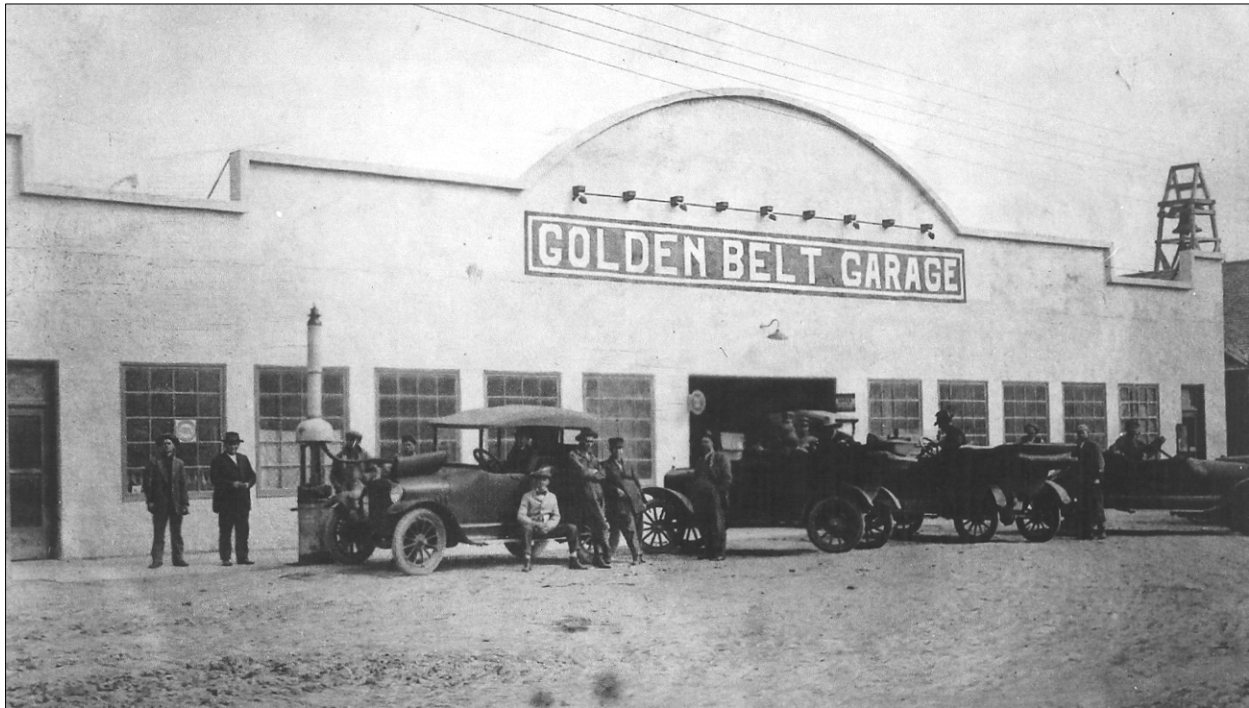
Figure 2. *Golden Belt Garage in about 1920. E.J. Eicher stands at the far left next to Ed E. Hoskin. The curbside gas pump stands next to the first car on the left. Source: Old Town Burlington.*

The garage at 615 Center and its surrounding block underwent significant change between 1913 and 1920. (See Fig. 13.) The garage building itself, along with the hay barn/blacksmith shop and the oil house all came down to be replaced by a large one-story 60-car garage with a curbside gas pump and a 400-gallon buried tank. In 1920, a new blacksmith shop stands adjacent to the garage and a hose house for the fire department's cart occupies the southeast corner. A tower with the fire bell stands behind the hose house. This is the building pattern depicted in a historic photograph of the Golden Belt Garage. (See Fig. 2.)

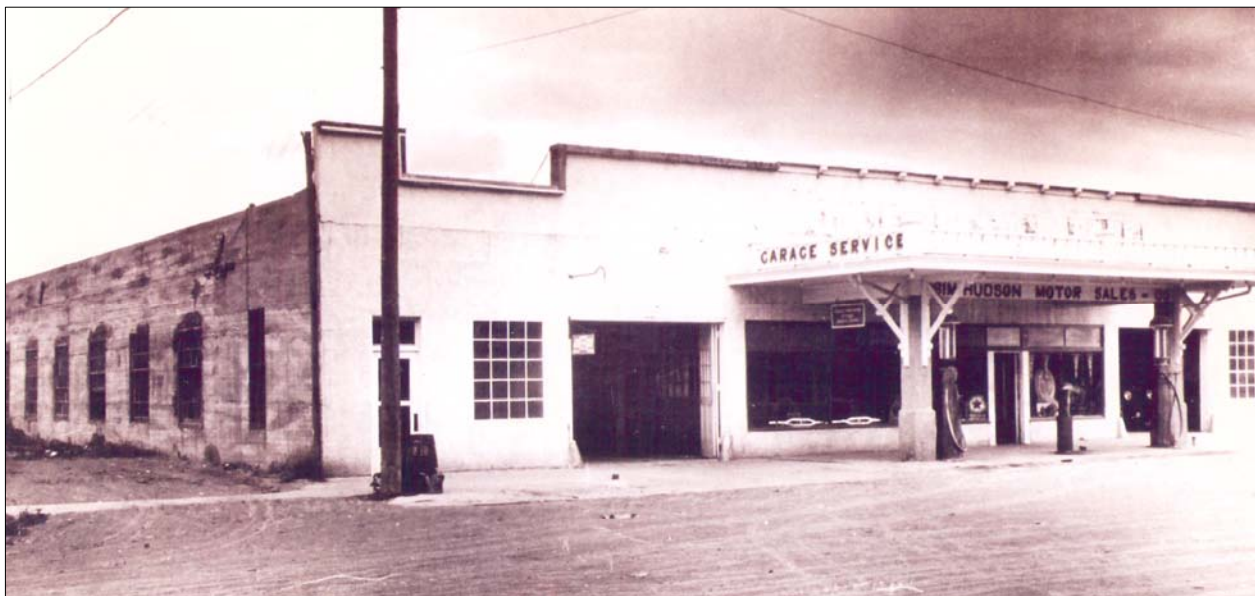
Figure 3. *Golden Belt Garage about 1927. The star in the window beside the gas pump indicates the business sold Texas Company (Texaco) petroleum products. Source: Old Town Burlington*

Under Sim Hudson's ownership, the building facade took on a changed appearance in the 1920s with the addition of a canopy extending over the new curbside gasoline pumps, as well as with the relocation and addition of vehicular doors and the replacement of some of the original multi-light casement windows with large display windows. The central curvilinear parapet was removed during this period. (See Figs. 3 and 4.)

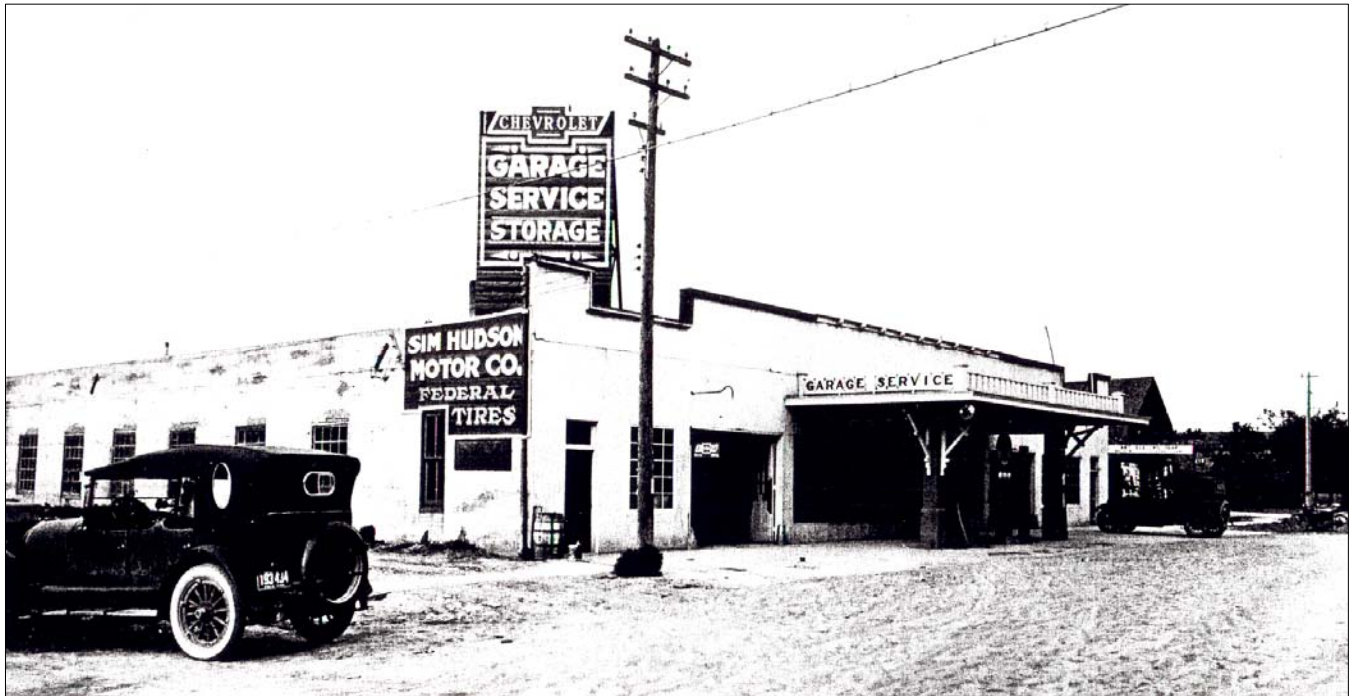
Figure 4. *Sim Hudson Motor Company in about 1927.*

The corner fire department hose house and fire bell are no longer standing. The presence of the large roof sign indicates the photo was probably taken after Figure 3. Source: Old Town Burlington

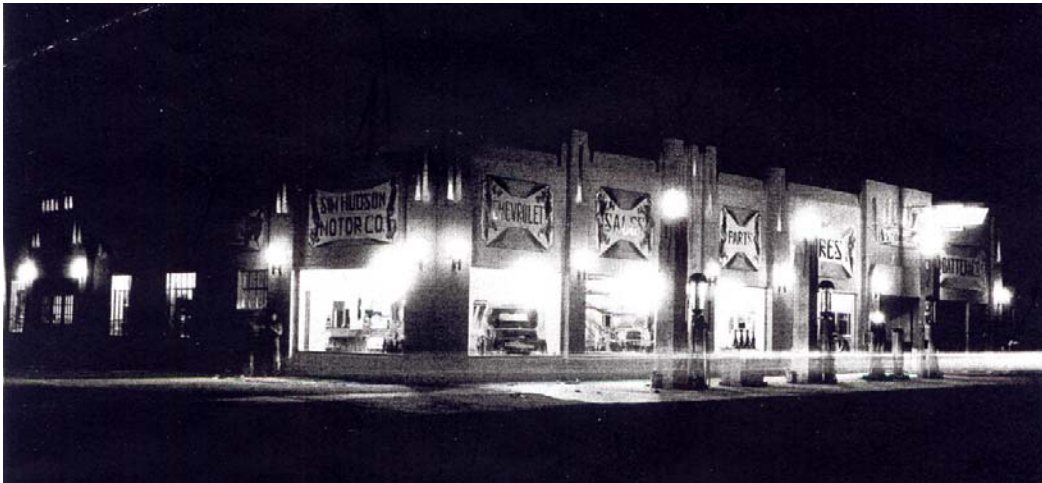
Figure 7. *The newly remodeled Sim Hudson Motors at night in 1932.*
Source: *Old Town Burlington*

The biggest change to the building's appearance came in 1932 with the completion of the new Art Deco style facade and showroom/office area. (See Figs. 7 and 24.) In addition to the stylistic changes, the new facade design reconfigured the entries and expanded the number of display windows.

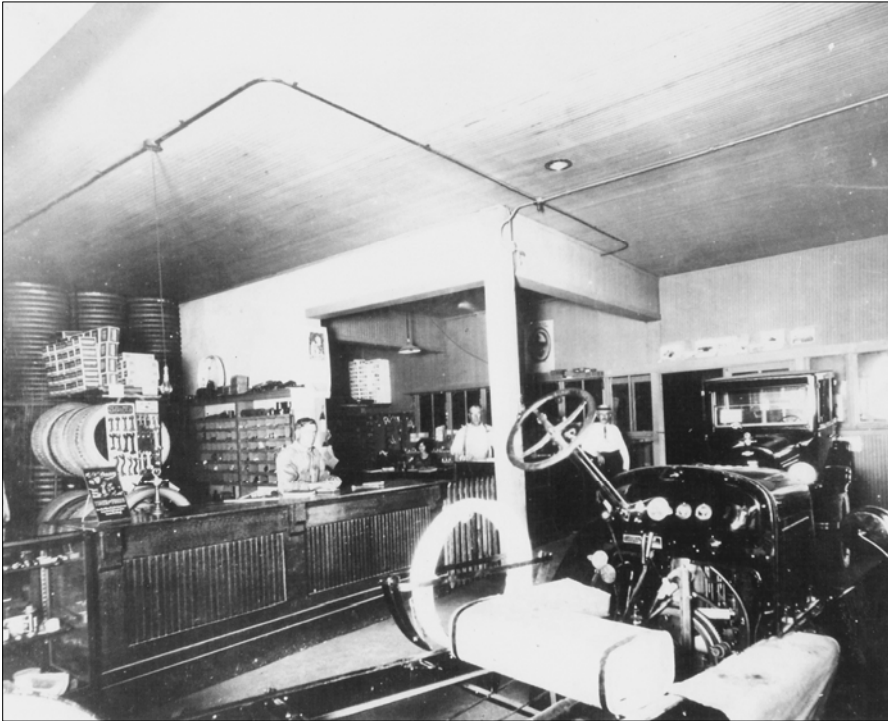
Figure 22. *Sim Hudson Motor Company parts department in the 1920s. Source: Old Town Burlington*

Automobile parts constituted a significant part of a dealer’s inventory and sales. Dealer mechanics used the parts in the repair of customer autos and additional parts were sold to the public. Figure 22 shows the Hudson parts department sometime in the 1920s. The

department was usually placed close to the mechanical service area to be convenient for mechanics. Many dealers located their parts departments adjacent or even behind the showroom so that parts customers would be exposed to the new car models. The photo of the Hudson parts department shows a partially assembled vehicle on display as a customer attraction and a road-ready new car model to the rear.

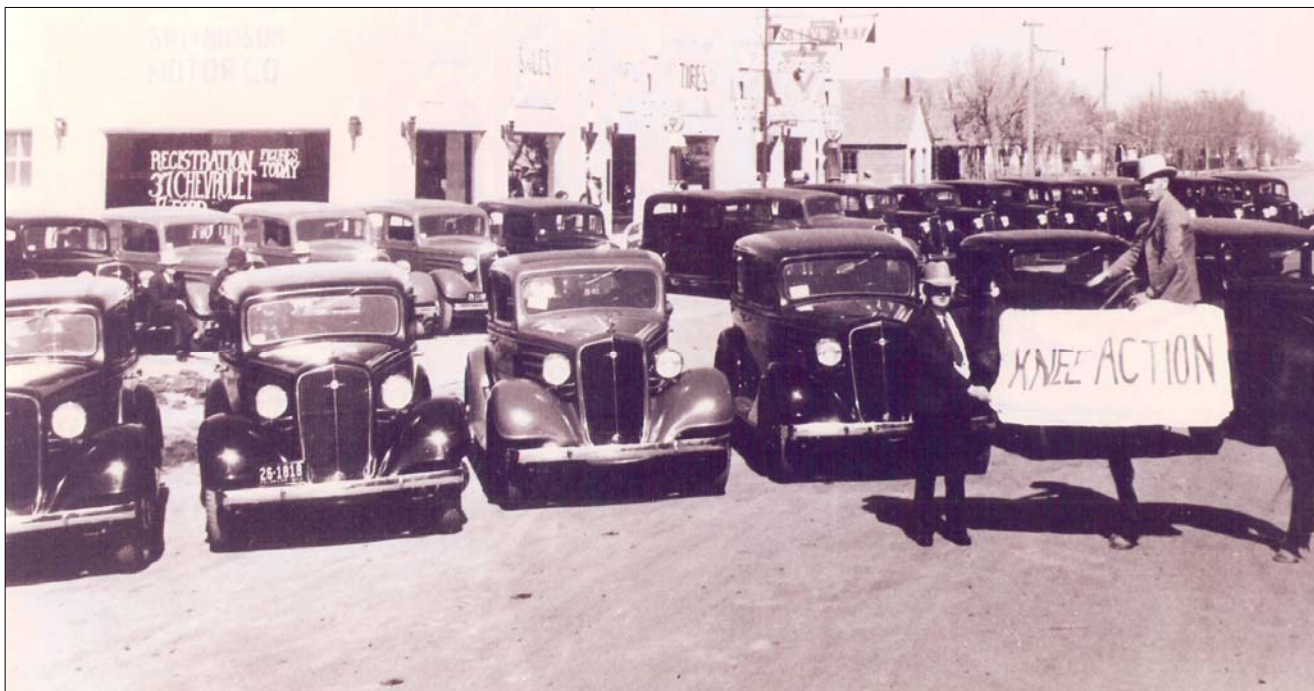
Figure 25. *Hudson Motor Company in 1934. Sim Hudson sits atop a horse to promote the new "knee action" suspension system of the 1934 Chevrolets. Source: Old Town Burlington*

Hudson Motors as it evolved from the Golden Belt Garage provided the mix of services typical of a pre-World War II automobile dealership. In addition to selling cars and trucks, Sim Hudson and his staff repaired and stored cars, sold parts to the public inside the building, and pumped gas and topped off oil crankcases at the curb. As an independent gas and oil retailer, Hudson Motors could enter into simultaneous agreements with more than one petroleum company and could change those affiliations over time. Figure 21 shows the dealership displaying signage for two brands of oil—City Services and Mobil. The brand of gasoline sold might have been either of these or yet another variety. In Figure 3, also around 1927, the window sign indicates the availability of petroleum products by the Texas Company (Texaco). The 1934 view of the dealership in Figure 25 includes Conoco (Continental Oil Company) gasoline signs.
