National Register of Historic Places Registration Form

Historic name: Rock Island Snow Plow No. 95580

Other names/site number: Union Pacific Snow Plow No. 900016 / 5LN.579

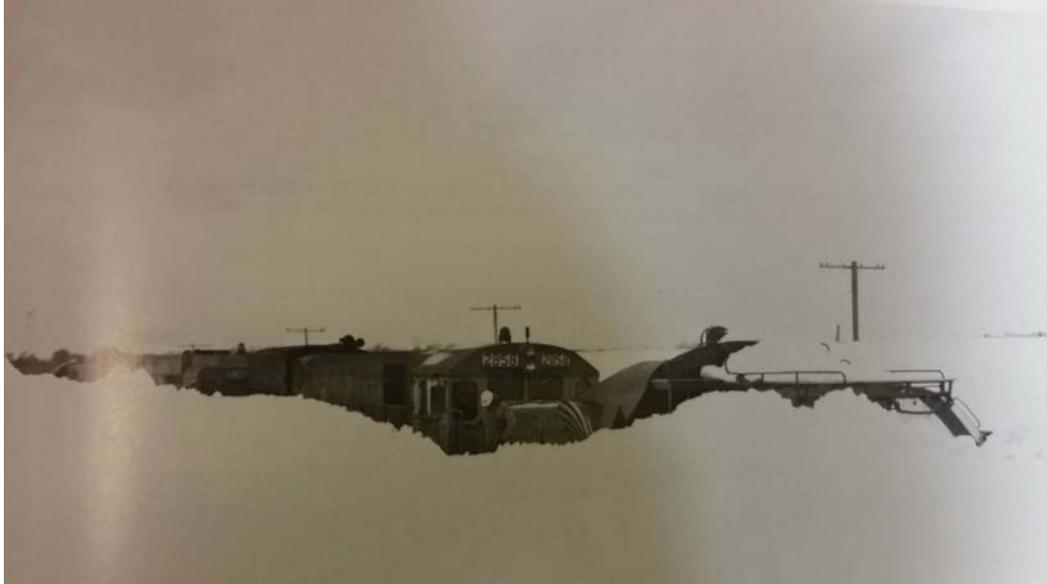
HP1 - UP Snow Plow No. 90013 being pulled into the clear on March 16, 1977 after derailling outside of Cheyenne Wells, Colorado. From James L. Ehernberger, "Engine Tender Snow Plows," *The Streamliner*. Volume 6, Number 3, p. 10; Union Pacific Historical Society, 1990.

HP1 - UP Snow Plow No. 90013 being pulled into the clear on March 16, 1977 after derailling outside of Cheyenne Wells, Colorado. From James L. Ehernberger, "Engine Tender Snow Plows," *The Streamliner*. Volume 6, Number 3, p. 10; Union Pacific Historical Society, 1990.

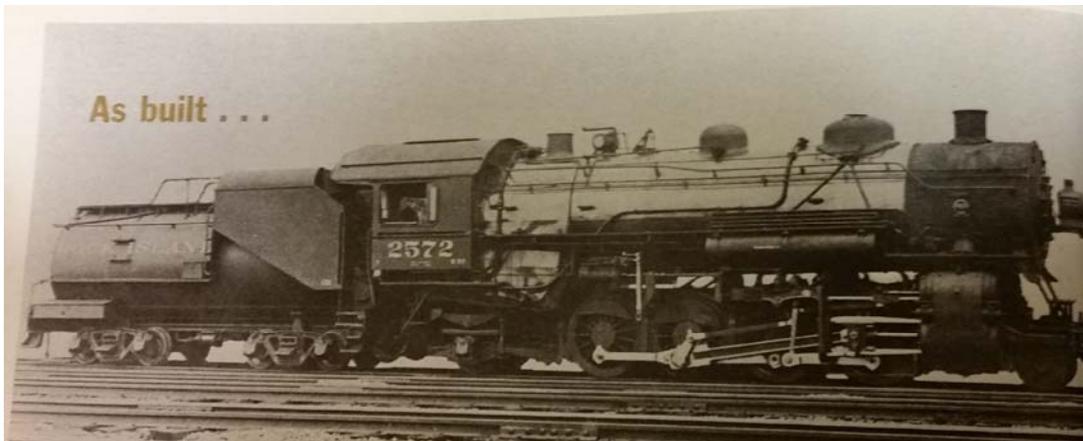
HP2 – An example of a Vanderbilt tender, with cylindrical tank on its side. From Ed Wojtas, "Rock Island's Very Own Tenders," *Trains: The Magazine of Railroading*. July 1969, p. 46.

Rock Island Snow Plow No. 95580 was built in 1951 from a former Rock Island tender, which itself was a 1920s modification of a Vanderbilt tender first purchased by the railroad in 1912 or 1913.⁵ Vanderbilt tenders were steel cylindrical tanks set on steel underframes (see Historic Photo 2); in the 1920s, when Rock Island's Vanderbilt tenders began to deteriorate at the junction between the curved side of the tank and the frame, the railroad rebuilt the bottom portion, resulting in a rounded top with flat sides that sloped down to a flat bottom (or semi-

HP2 – An example of a Vanderbilt tender, with cylindrical tank on its side. From Ed Wojtas, "Rock Island's Very Own Tenders," *Trains: The Magazine of Railroading*. July 1969, p. 46.

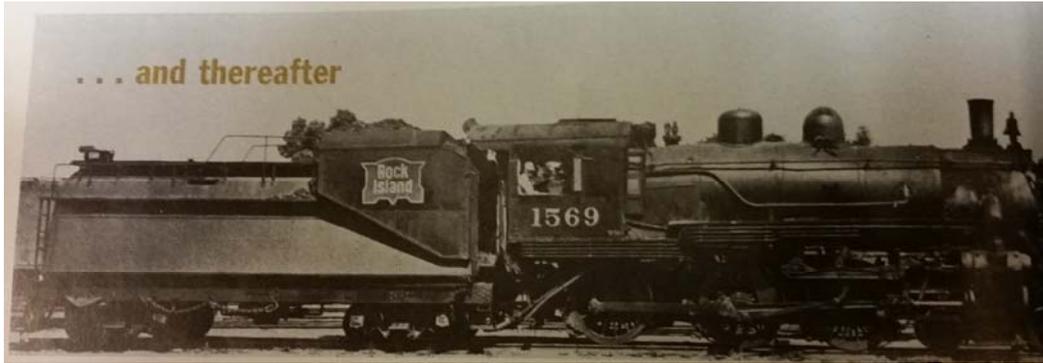
HP3 – An example of a semi-Vanderbilt tender that expanded the base of the cylindrical original tank with sloping sides down to the frame. From Ed Wojtas, “Rock Island’s Very Own Tenders,” *Trains: The Magazine of Railroading*. July 1969, p. 46.

Vanderbilt), which ultimately allowed for more water storage within the tank (see Historic Photo 3). As discussed in an article on Rock Island's tenders,

HP3 – An example of a semi-Vanderbilt tender that expanded the base of the cylindrical original tank with sloping sides down to the frame. From Ed Wojtas, "Rock Island's Very Own Tenders," *Trains: The Magazine of Railroading*. July 1969, p. 46.

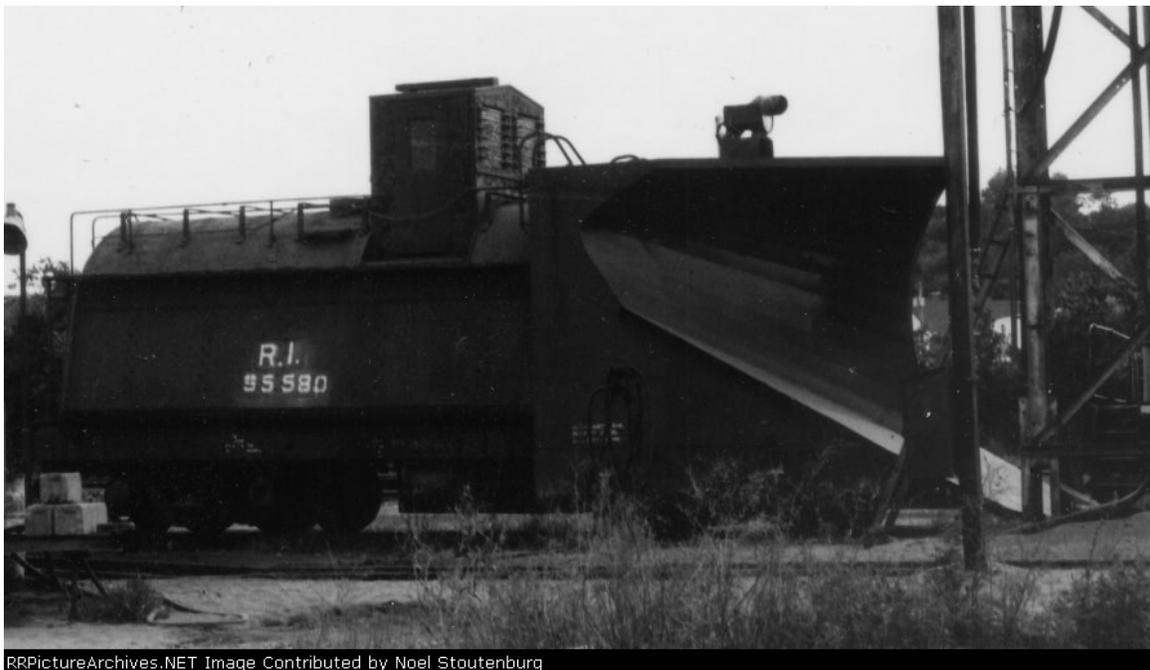
HP4 – Photograph of Snow Plow 95580 in Silvas Illinois, August 15, 1978 by Noel Stoutenburg, As posted on RR Picture Archives.net (<http://www.rrpicturearchives.net/showPicture.aspx?id=845714>, accessed May 30, 2018)

HP4 – Photograph of Snow Plow 95580 in Silvas Illinois, August 15, 1978 by Noel Stoutenburg. As posted on RR Picture Archives.net (<http://www.rrpicturearchives.net/showPicture.aspx?id=845714>, accessed May 30, 2018)

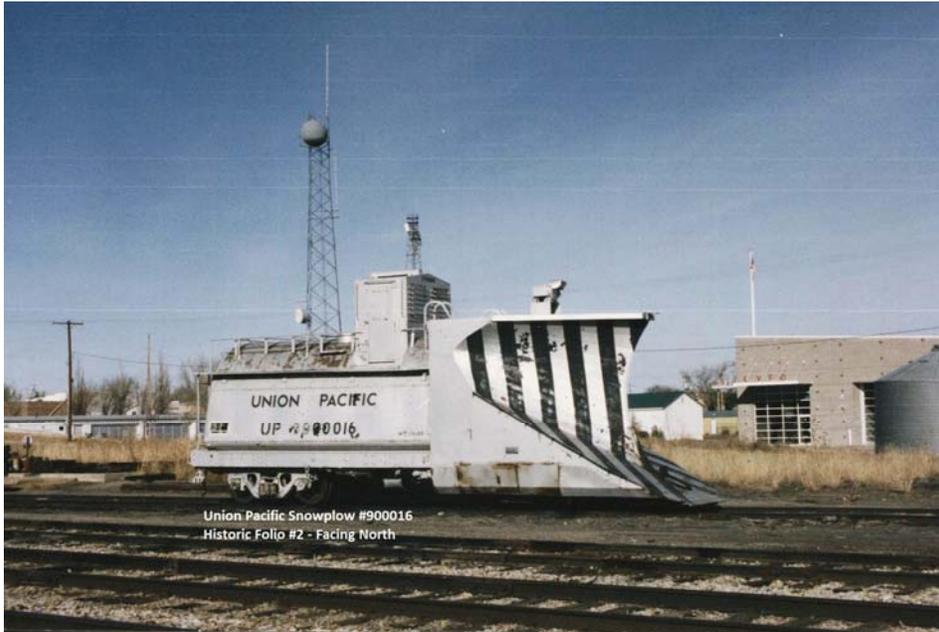
HP5. Snow Plow No.95580 (then 900016) at Limon Heritage Museum, ca. 2008.

HP5. Snow Plow No.95580 (then 900016) at Limon Heritage Museum, ca. 2008

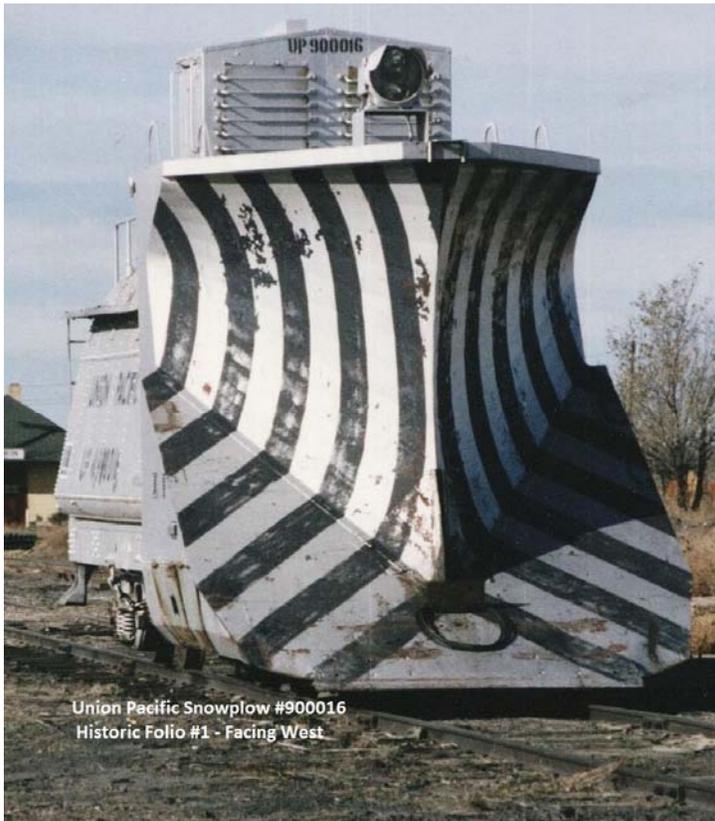
HP6. Close up of Snow Plow blade, ca. 2008.

At the front, or “A” end, of the snow plow is the single-track wedge plow itself (photo 1-2). Measuring 16’-7” from the tip of the plow to the edge of the plow box that attaches to the tender, the plow has an angled horizontal blade that lifts snow upward, which is then forced by the center vertical blade to either side of the track. The plow measures 12’-4” tall from the rail to the top edge, 10’-0” wide at the top, 11’-0” wide at its full width, and 7’-0” wide at the rail. A headlight is mounted at the top of the plow.

HP6. Close up of Snow Plow blade, ca. 2008.
